Environmental Monitoring Report

for Redevelopment and
Enhanced Oil Recovery (EOR)
Programme

April 2023 ~ September 2023

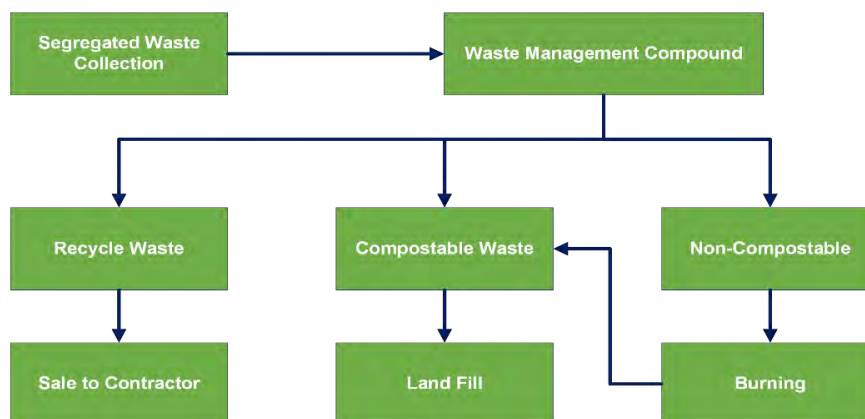
Figure 2: Waste Management Flowchart

Brief Waste Management Process is described as follows:

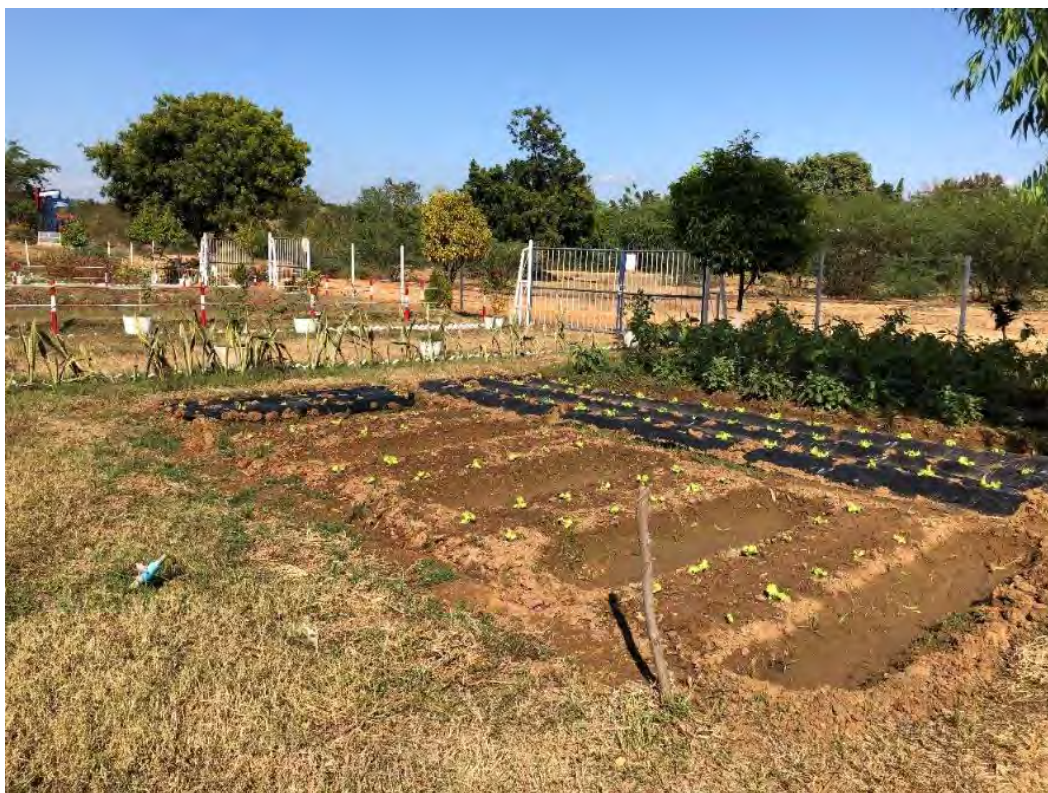
Based on our self-monitoring records spanning six months from October 2022 to March 2023, the composting process has yielded approximately 1265 kg of compost. While the process is notably rapid during summer, the composting bacteria do not function optimally under neutral conditions in the rainy season.

Figure 4: Reusing Composts in the Plantation Field at WMC

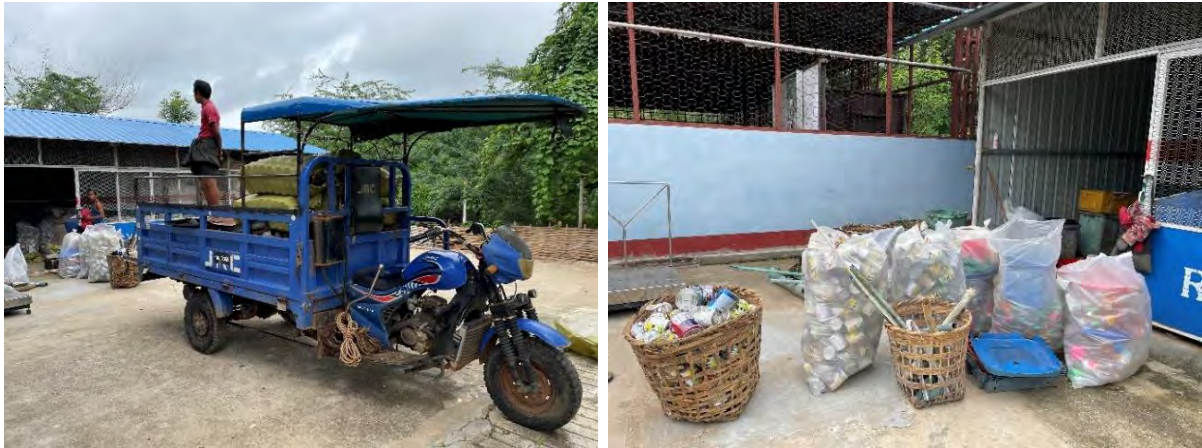
At our facility, we collect and sell recyclable materials such as glass, paper, cardboard, plastic bottles, and materials to third-party vendors. To ensure proper recycling, these materials are separated from general waste during the collection process.

General Waste is collected from all areas within the Mann Field Operations and temporarily stored at the Waste Management Compound. Waste collection is carried out periodically every week using Jumbo big bags to reduce plastic bag usage, which can be reused multiple times. Additionally, the plastic bags used in the waste bins are also reused, except for the organic waste bin.

Figure 5: Reselling of Recycle Waste at WMC

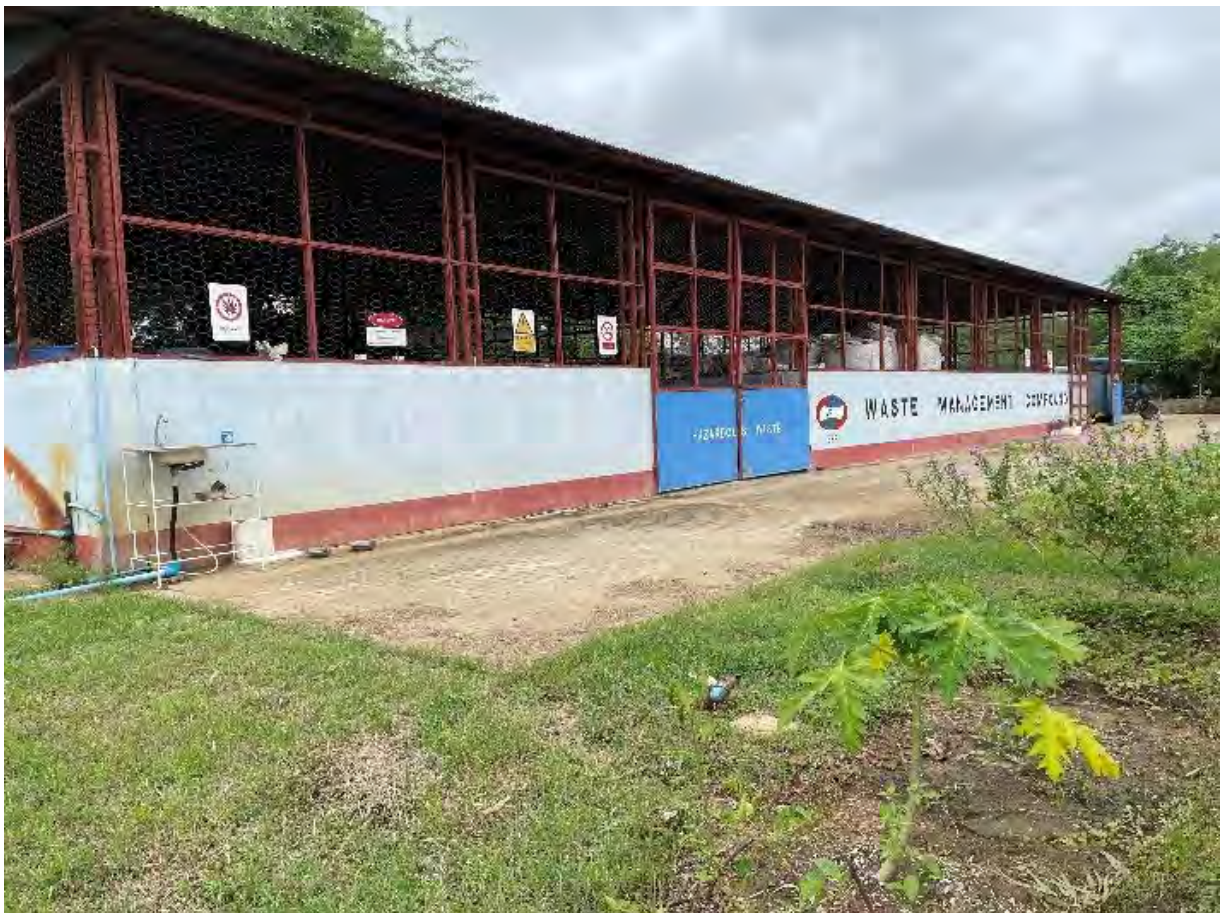
Figure 6: Waste Management Compound (WMC)

General Waste Storage in WMC

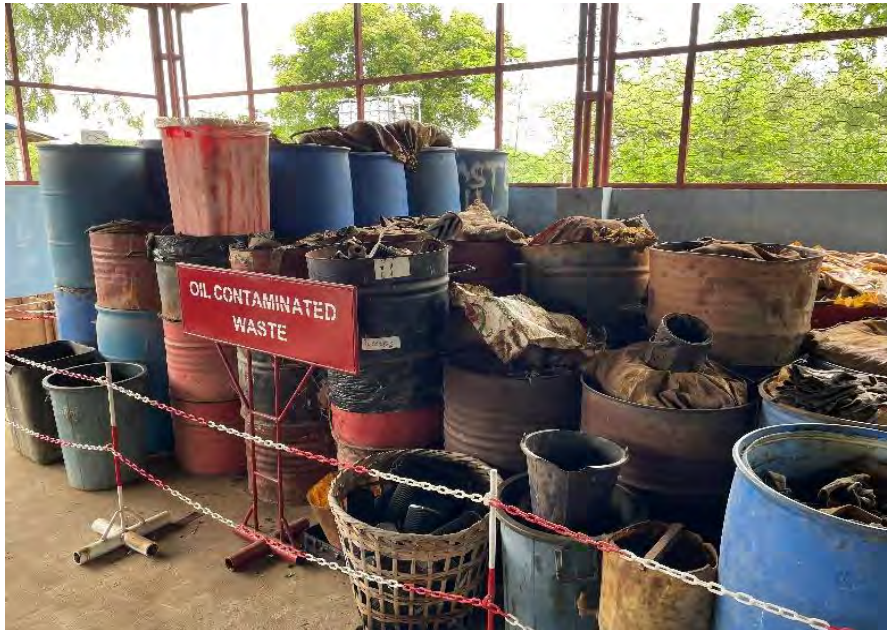
Figure 7: Oil Contaminated Waste Stored at WMC

From April 2023 to September 2023, a total of 7,283 kg of hazardous waste is collected from all work-related areas and is properly stored at the Waste Management Compound. The volume of hazardous waste collected was high in September 2023, with most of it being dry sludge from GOCSs. The dry sludge/ produced sand is temporarily stored at the Waste Management Compound, while the wet sludge is stored at the Sludge Management Compound.

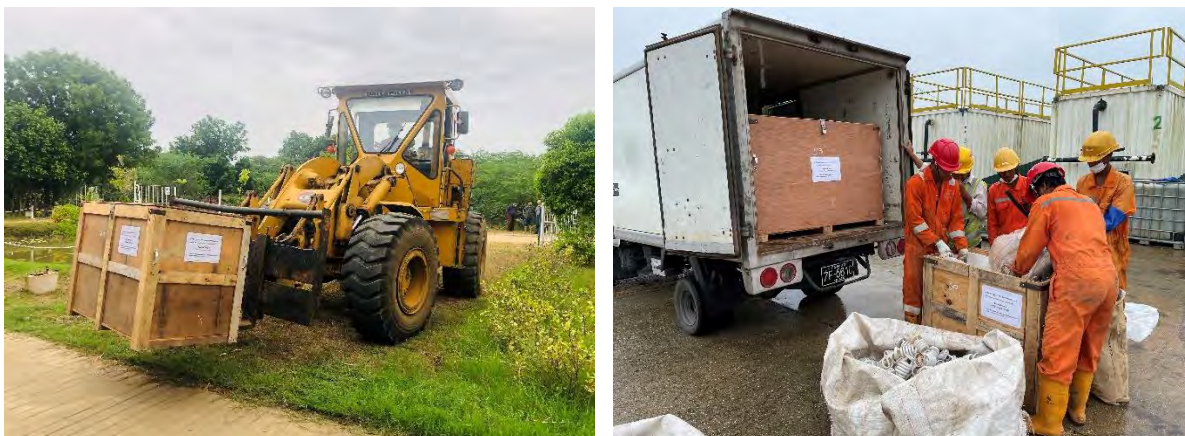
Figure 8: Disposal of E-Waste to DOWA on 22 August 2023

Of the hazardous waste inventory held at WMC, approximately 260.0 kg of fluorescent lamps and bulbs were properly disposed of at DOWA following receipt of the updated quotation for solid waste disposal.

As per our ECC commitments, the hazardous waste is managed under waste management procedure and E-waste about (260.0) kg. was disposed to licensed third party DOWA on 22 August 2023.

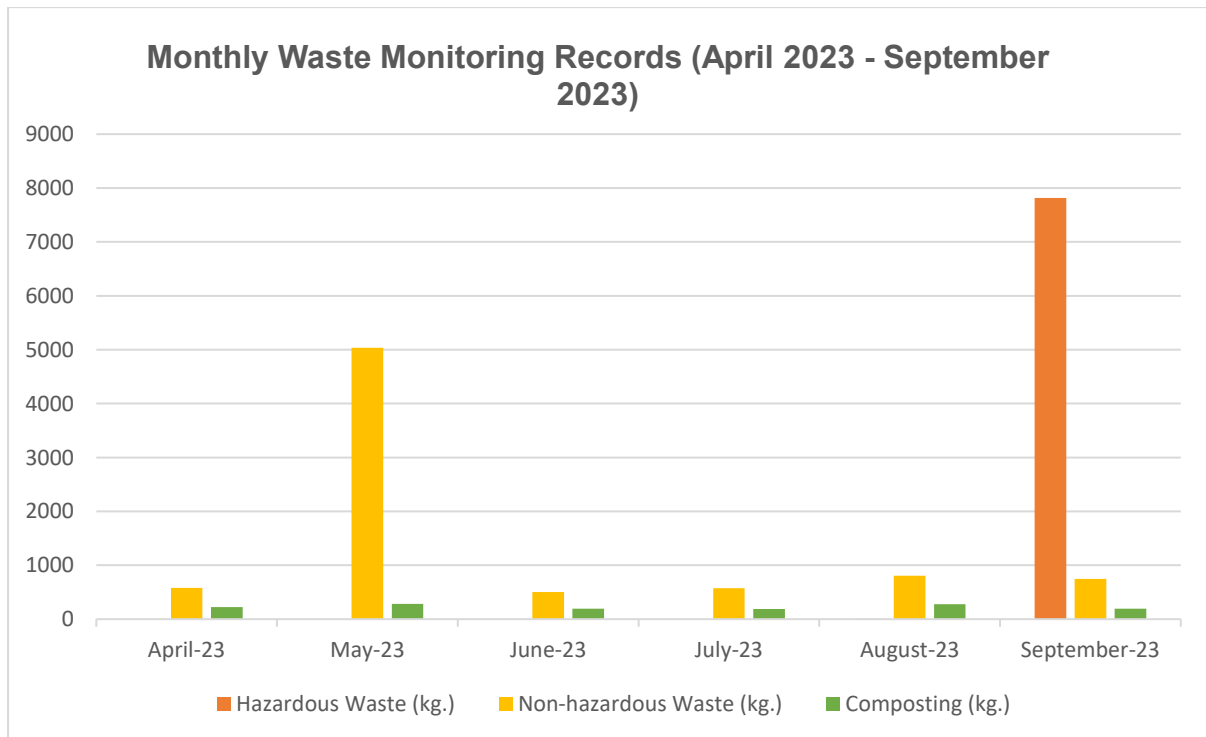
Figure 9: Monthly Waste Monitoring Records from Apr 2023 - Sep 2023

Month	Hazardous Waste (kg.)	Non-hazardous Waste (kg.)	Composting (kg.)
April 2023	0	580	225
May 2023	0	5,036	285
June 2023	0	503	195
July 2023	0	572	190
August 2023	5	806	285
September 2023	7,818	750	195
Total	7,283	8,247	1,375

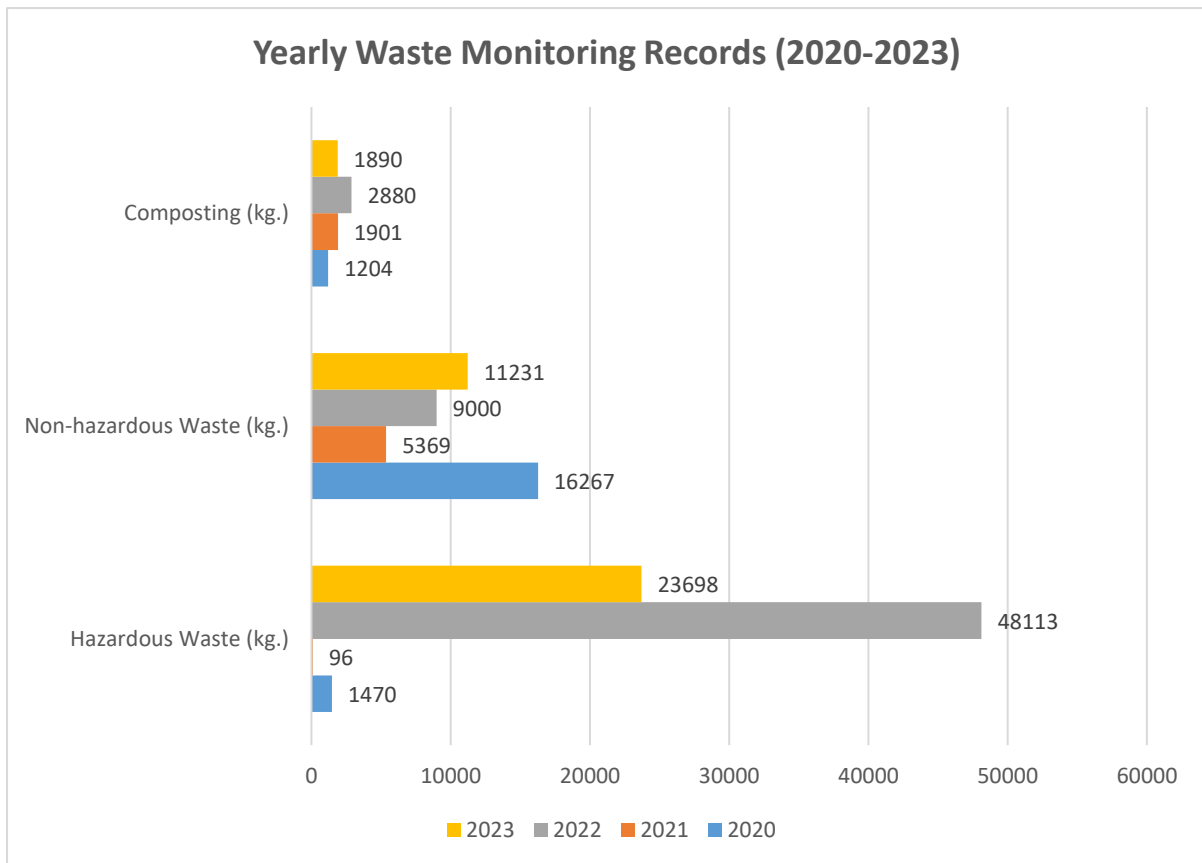
Figure 10: Yearly Waste Monitoring Record (2020 - 2023)

Year	Hazardous Waste (kg.)	Non-hazardous Waste (kg.)	Composting (kg.)
2020	1,470	16,267	1,204
2021	96	5,369	1,901
2022	48,113	9,000	2,880
2023 (up-to September)	23,698	11,231	1,895

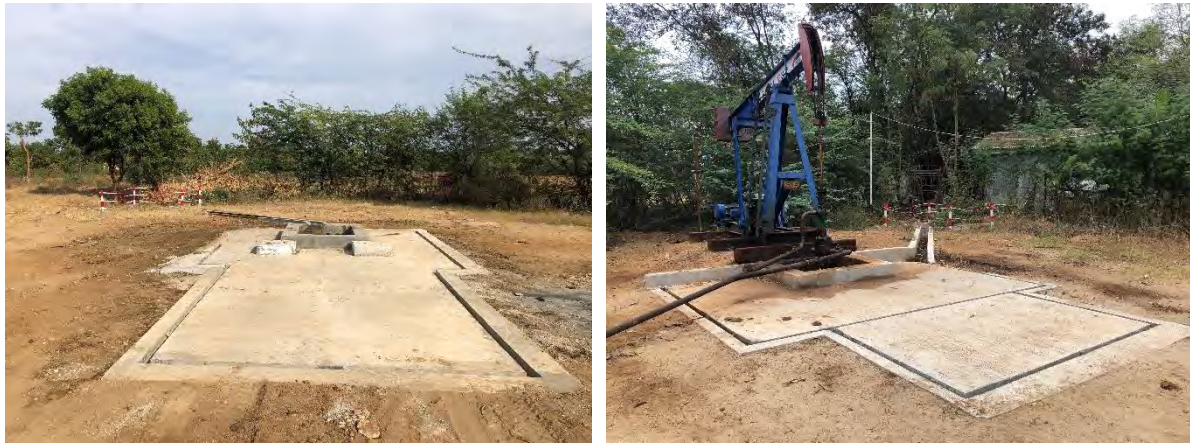
Figure 24: Concrete Pad and Additional Cellar at M-290 and M-554

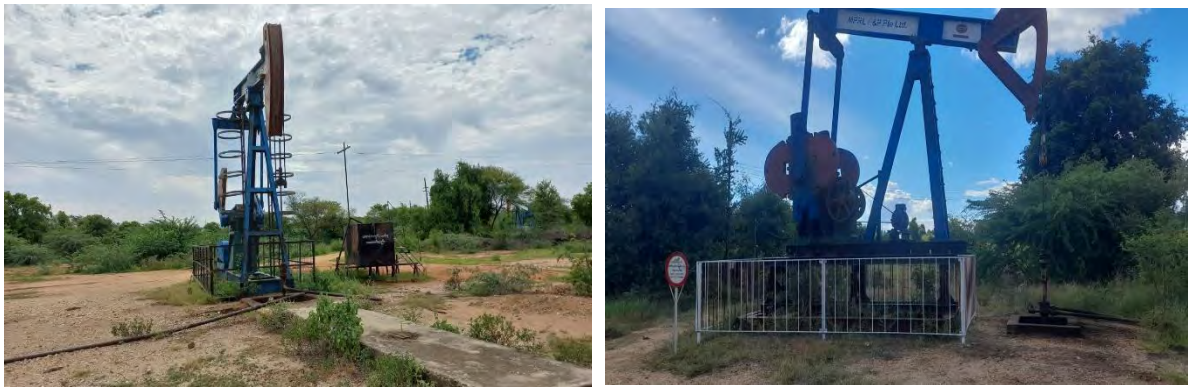
Figure 25: Concrete Pad and Additional Cellar at M-290 and M-554

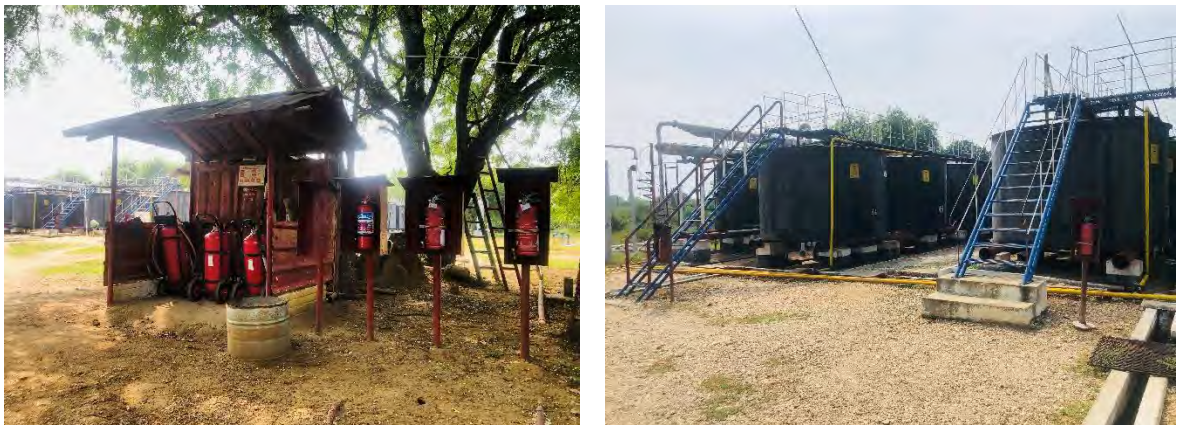
Figure 26: Fire Extinguishers at GOCS-2 and GOCS-3

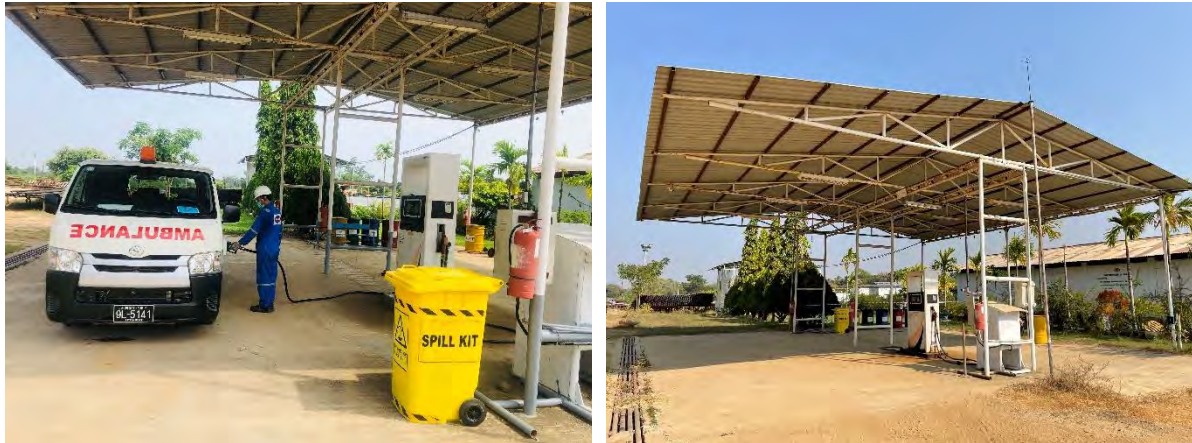
Figure 27: Fueling Station at Mann Oil Field

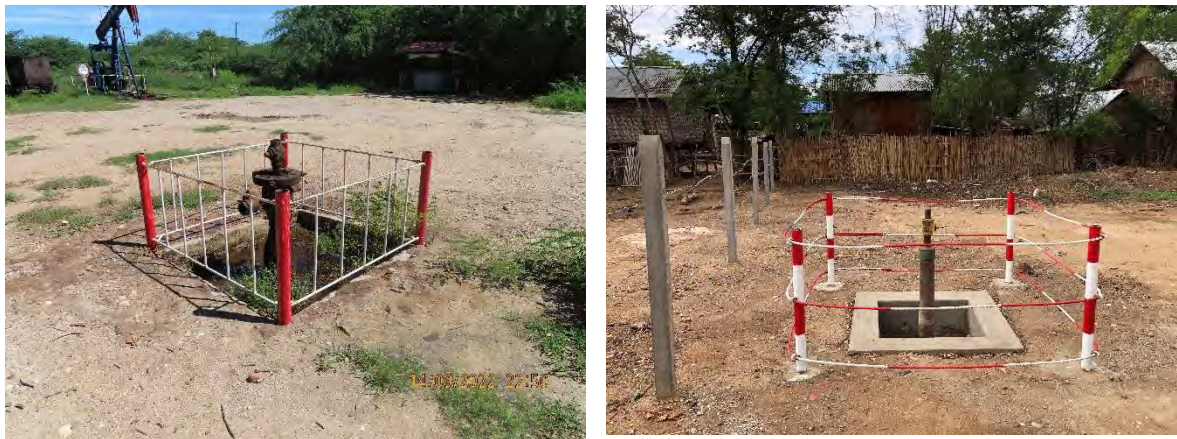
Figure 28: Shut-in Wells of M-58 and M-184

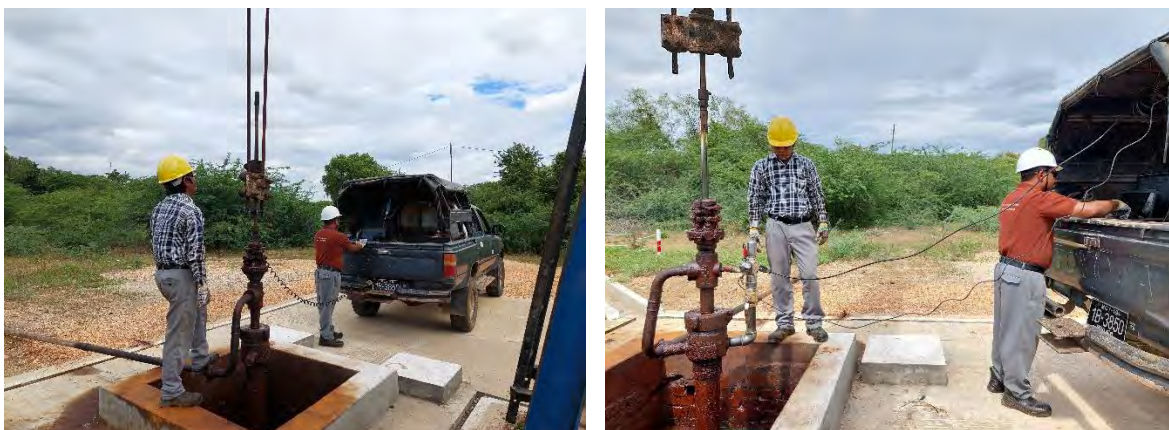
Figure 29: Regular Echo Metering at Selected Wells

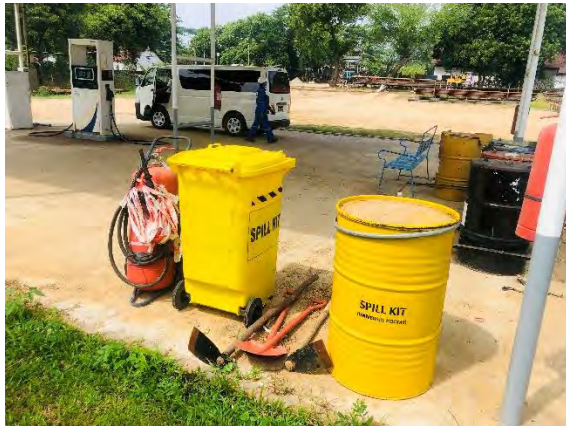
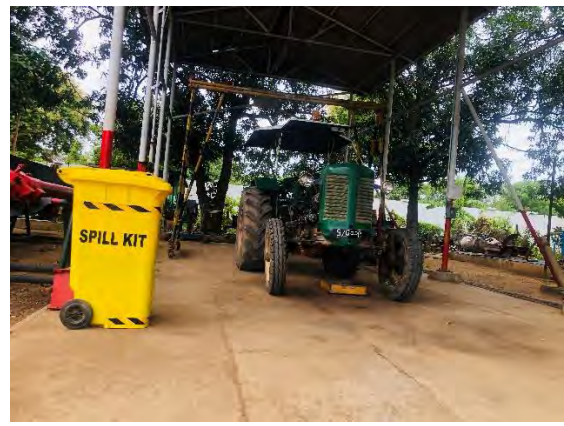
Figure 30: Spill Kits at Work Places

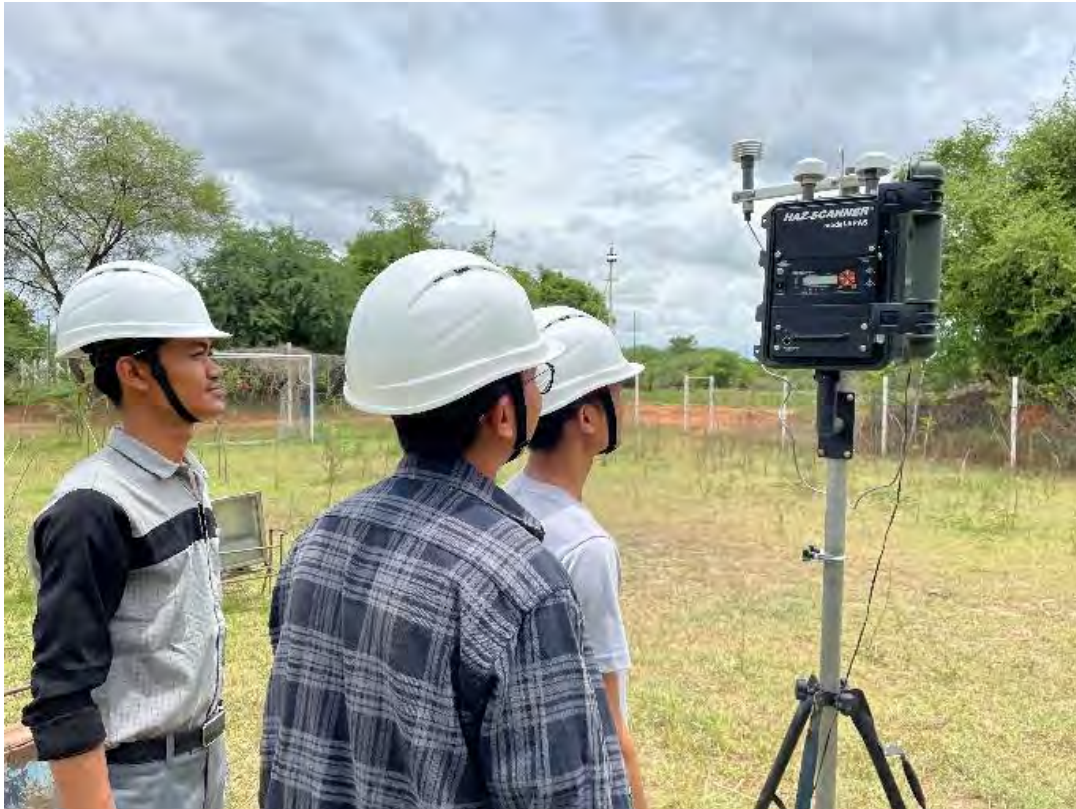
Figure 36: Air and Noise Quality Monitoring at Z3AQN

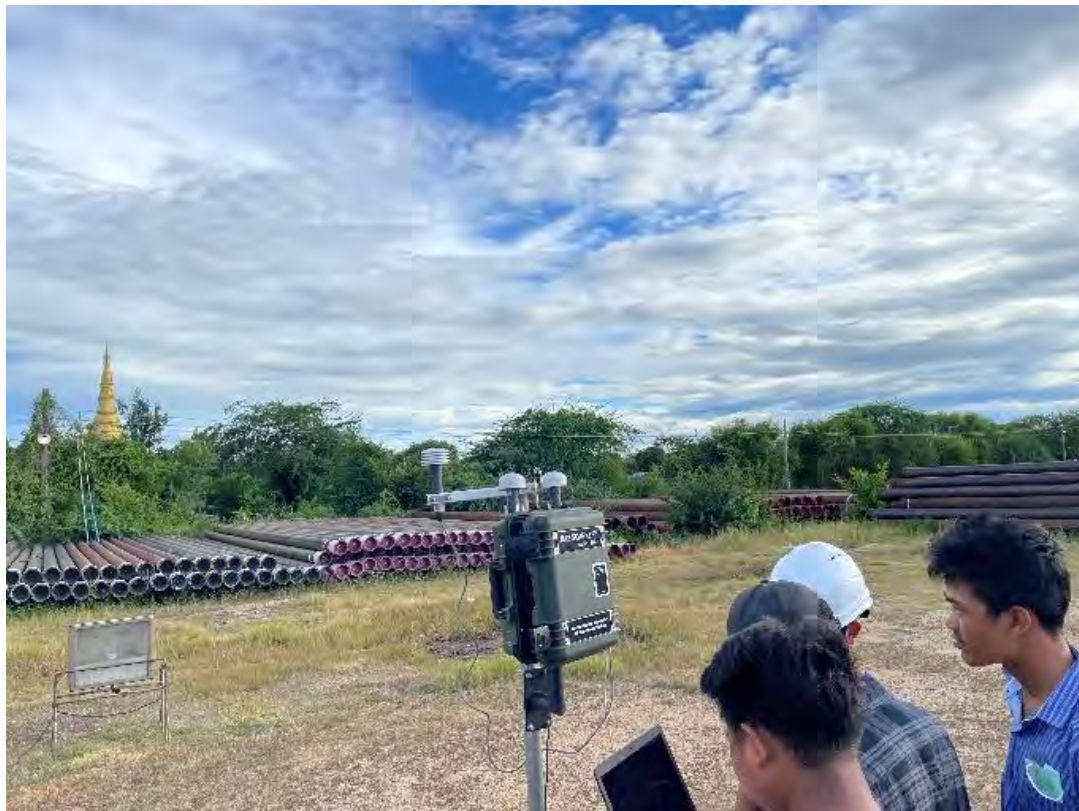
Figure 37: Air & Noise Quality Monitoring at Z4AQN

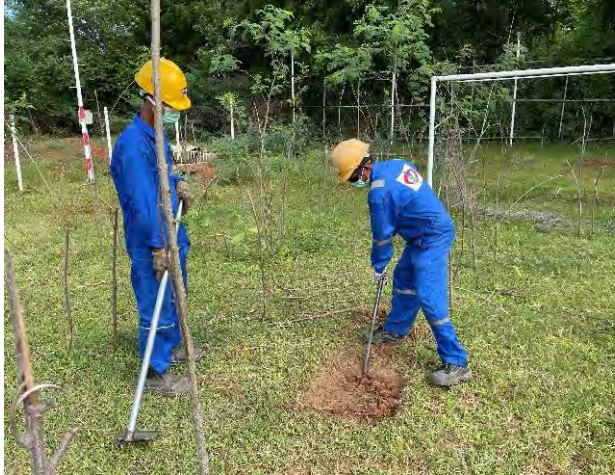
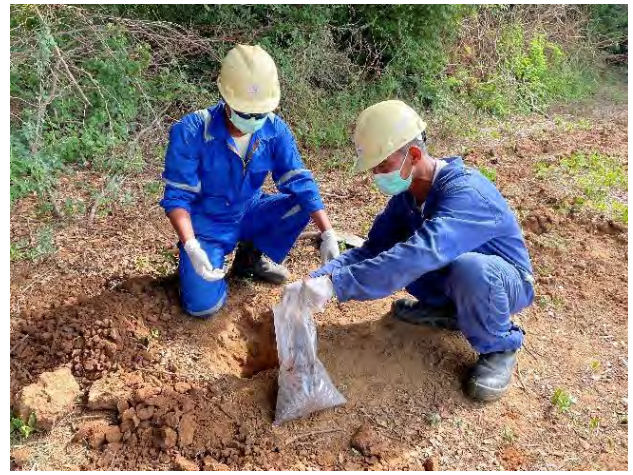
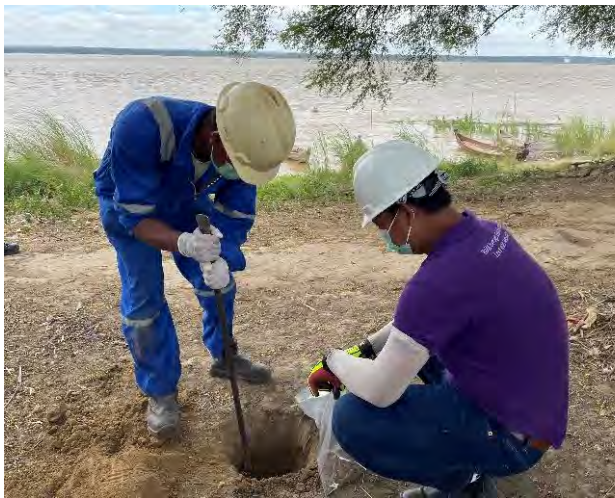
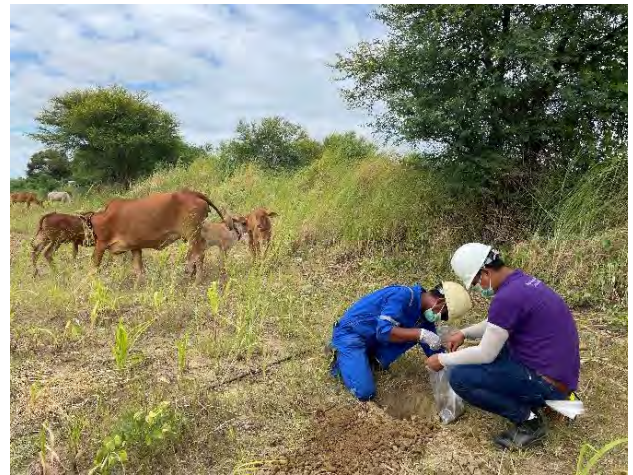
Figure 39: Soil Quality Monitoring at Z3S1, Z3S2, Z4S1, and Z4S2

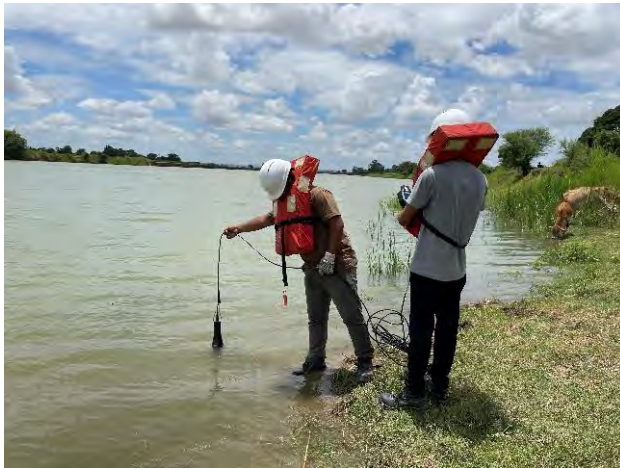
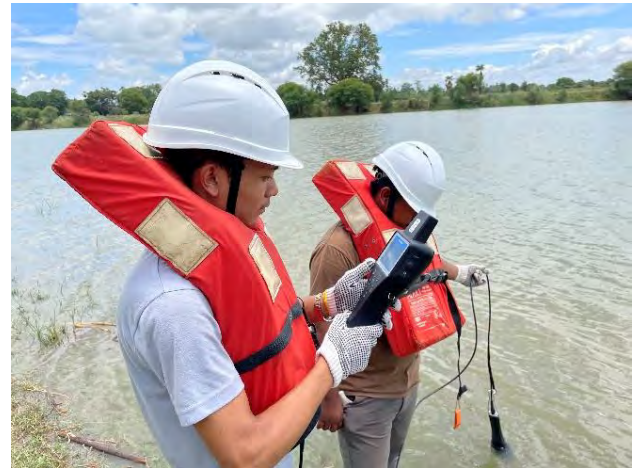
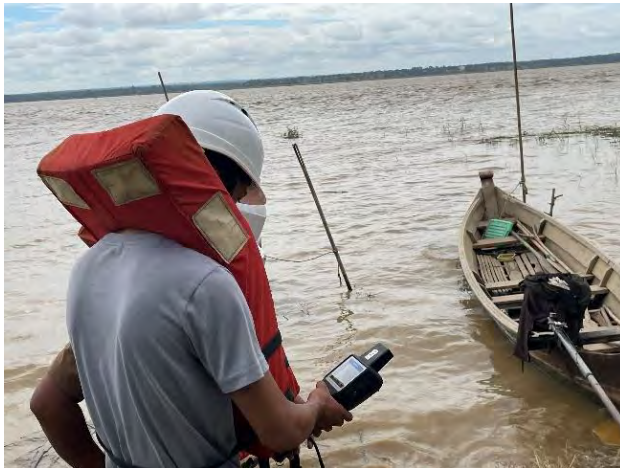
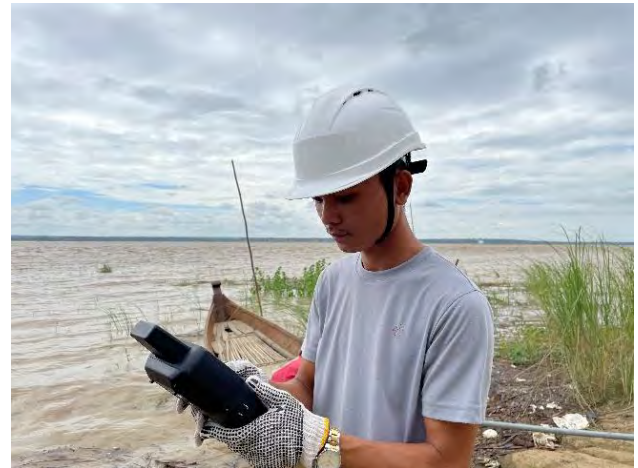
Figure 40: Surface Water Quality Monitoring at Z3SW1, Z3SW2, Z4SW1, and Z4SW2

As per the monitoring results of surface water in July 2023 as shown in Table 20, BOD5 value at Z3SW1 is overing the NEQEG. The sample water from that point is collected from Mann Creek and it may be many reasons such as agricultural runoff, natural sources of organic matters due to rainfall, etc. The high TSS is resulted at Z4SW1 and Z4SW2, the sample water of Ayeyarwady river, may be the high natural background turbidity level of river and water level rising and erosion of soil in a rainy season.

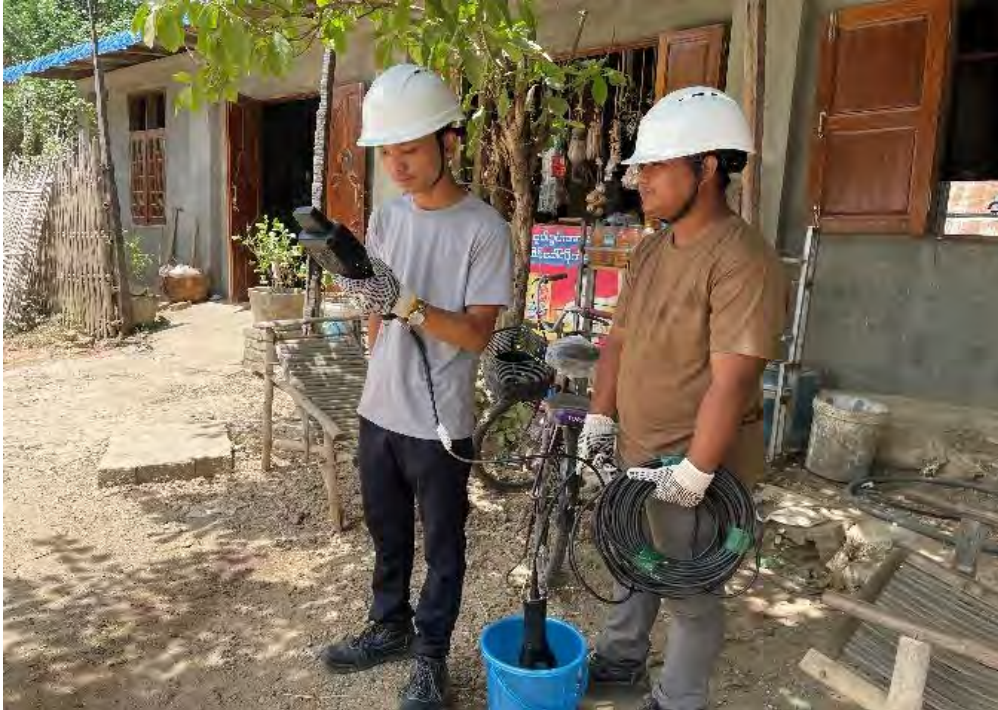
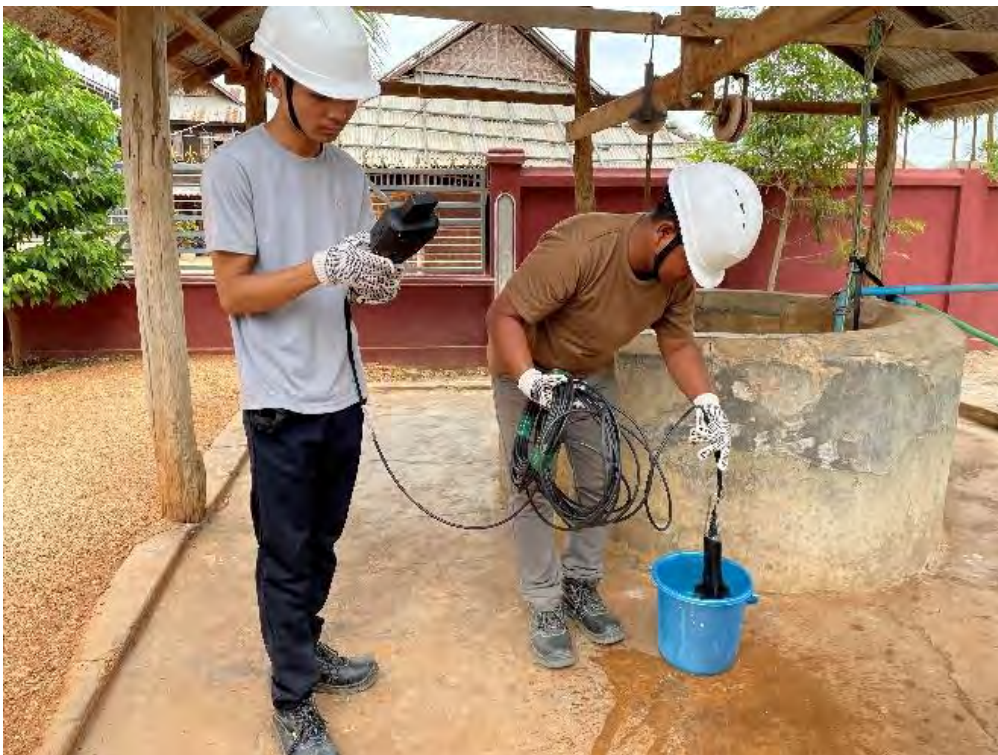
Figure 42: Groundwater Quality Monitoring at Z3GW1 and Z4GW2

The results of groundwater quality monitoring are summarized in Table 22. As per the results, the BOD₅ value is higher than the WHO Drinking Water Quality Standard at all locations but other parameters are complied with the standards and we found that BOD₅ value showed overing at time of the baseline water sample monitoring for EIA report in 2015.

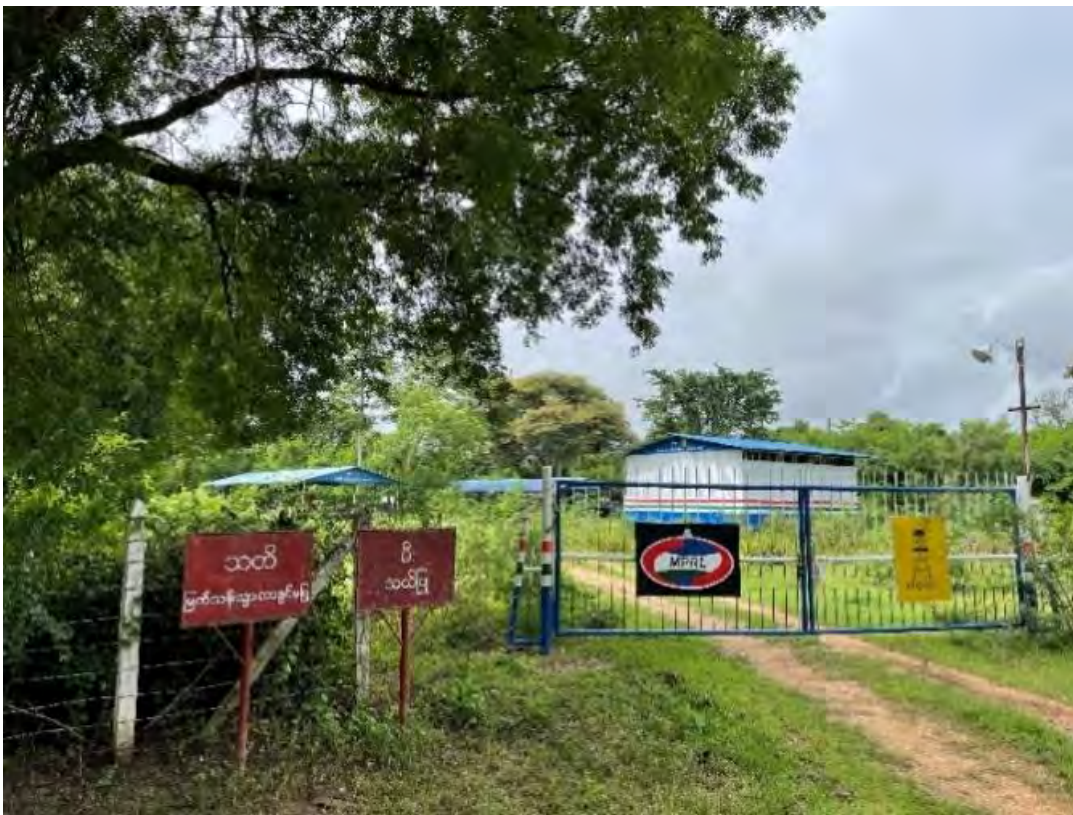
Figure 43: Sludge Management Compound (SMC)

Dried sludge, weighing approximately 112.4 tons (estimated weight), is currently being stored temporarily at the Waste Management Compound and at the Sludge Management Compound (extended dried sludge storage shed).

Currently, all the collected wet sludge is being stored properly in two concrete pits to ensure compliance with the NEQEG guideline levels for Onshore Oil and Gas Development. Any hazardous waste will be disposed of according to the commitments made in the ECC.

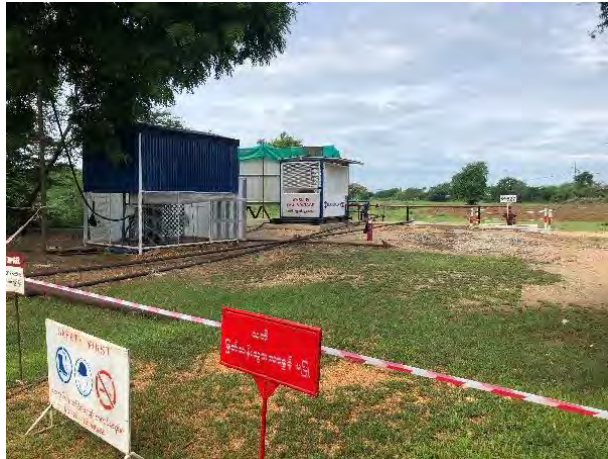
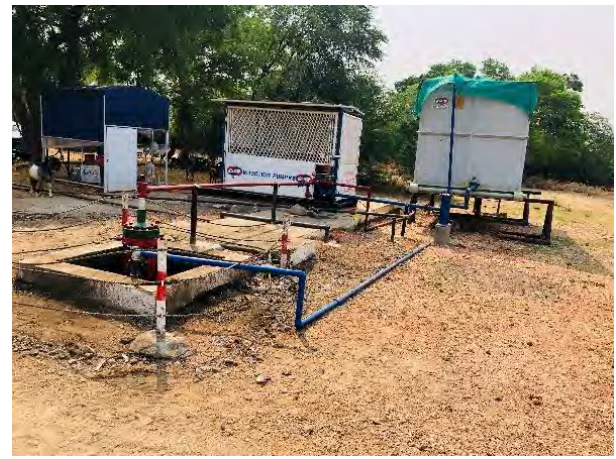
MPRL E&P is undertaking to inject all produced water (100%) into the shut-in wells by using 8 units of injection pumps to meet guideline levels in NEQEG for Onshore Oil and Gas Development.

Figure 44: Produced Water Injection at Shut-in Wells

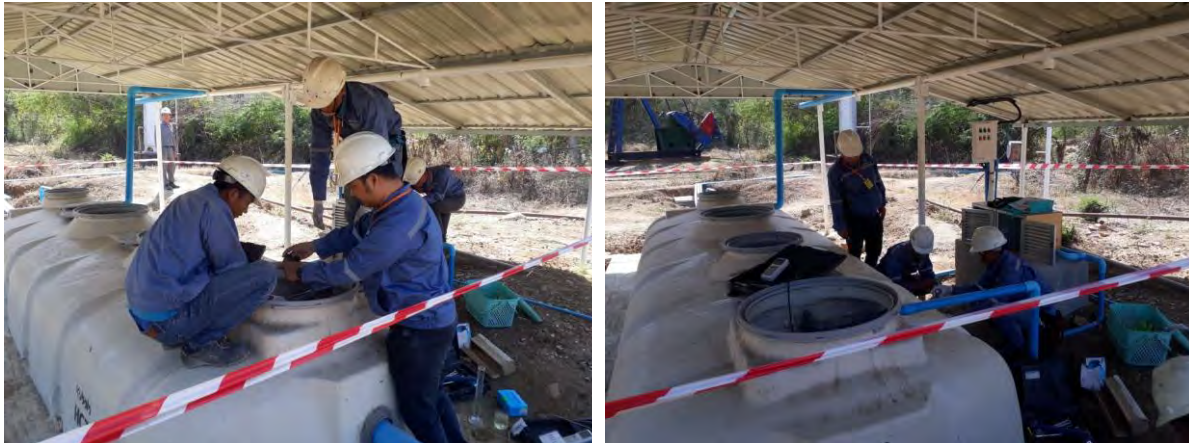
Figure 47: Desludging and Third-party Regular Maintenance of Bio-filter

Regular safety meetings and toolbox talks are held to raise awareness about water conservation, energy conservation, and water pollution among all crew members. Additionally, inspections are conducted to ensure that there are no leaks or wastage of water from pipelines and basins during routine camp inspections.

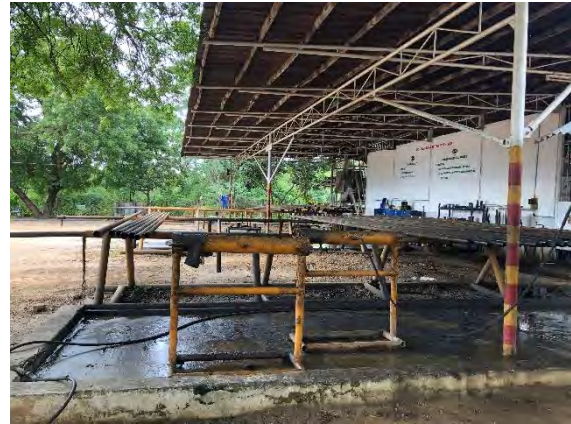
At the Mann field warehouse, the team previously conducted hydro tests on tubing in a designated pressure test area. However, the field team has since minimized water usage by implementing a recycling system that uses zero discharge recycled water for these tests.

Figure 48: Warehouse Tubular Section

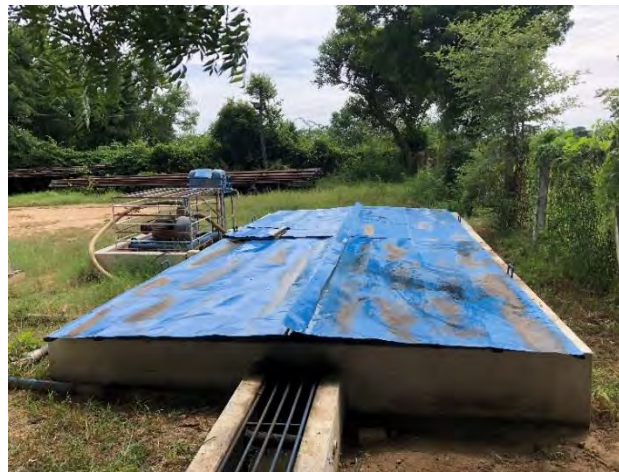
Figure 49: Warehouse Zero Discharge Tank

The hydro-test water monitoring schedule was carried out during the month of July 2023. The monitoring results revealed that all parameters complied with the NEQEG guidelines, except for the BOD₅ value. Hydro-testing involves using water to pressurize and verify the integrity of pipes, tanks, and other equipment. During this process, the water can absorb organic matter, oils, greases, and other contaminants. The high BOD₅ value in the hydro-test water is due to the accumulation of organic matter and chemicals during testing. To prevent contamination of natural water sources, we recycled the water using a zero-discharge tank instead of disposing of it after testing, and used appropriate filtration and settling systems.

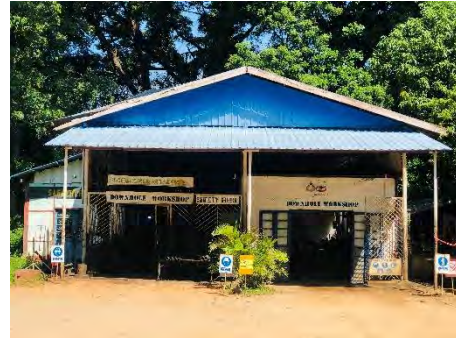
During the monitoring period from April 2023 to September 2023, water quality monitoring was conducted for the discharge of water from the equipment maintenance workshop (Down-hole Workshop) into the ZERO Discharge Tank. In July 2023, we monitored a total of twenty-nine parameters, and all of them complied with the NEQEG, except for BOD5, ammonia, oil and grease, and total coliform bacteria. The types of activities conducted in the workshop can have a significant impact on water quality. The Down-hole workshop draws its raw water from Mann creek, which may be contaminated. Additionally, dry leaves, bird feces, and ripened fruits in the surrounding environment can introduce total coliform bacteria into the zero-discharge tank. This may cause an accumulation effect due to storage conditions, which could explain why the total coliform count exceeded the limit. The rain water may also carry pollutants into the wastewater storage system.

Figure 50: Down-hole Workshop

The water used in the daily operation of the down-hole workshop was collected in a concrete tank via a drain line and reused for recycling, thus avoiding discharge to the environment.

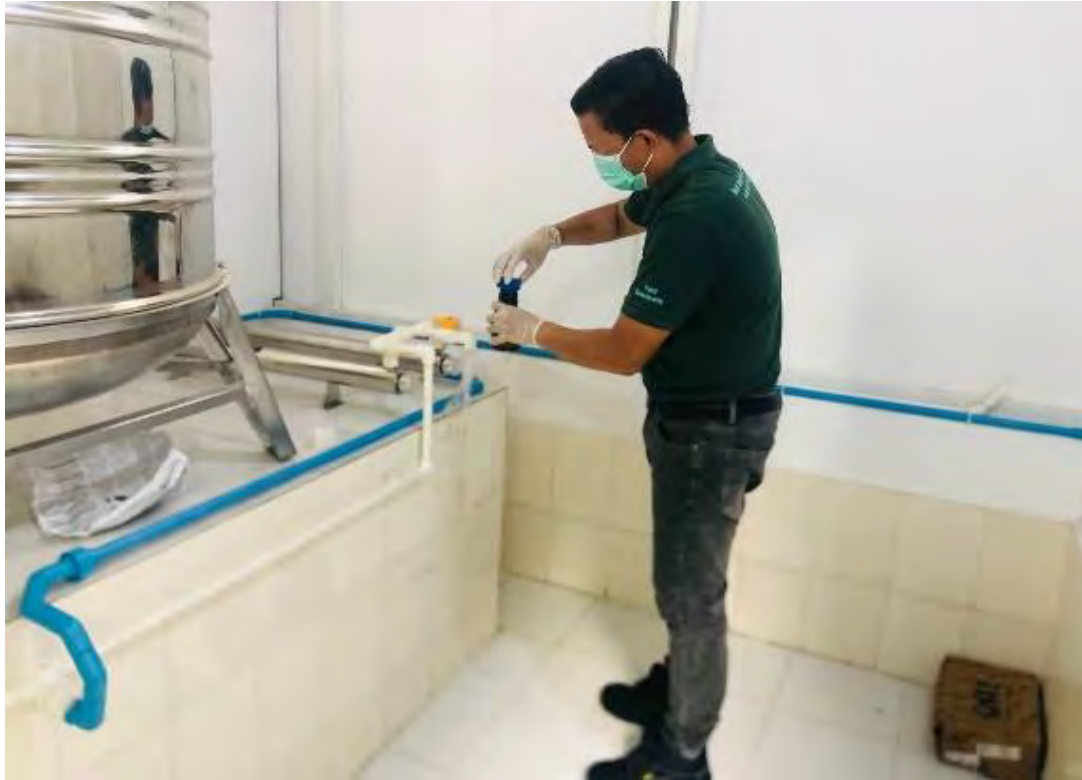
Figure 52: Water Sample Collection at RO Drinking Water System at Mann Field Base Camp

Access to safe drinking water is crucial for everyone's wellbeing, which is why a Reverse Osmosis (RO) drinking water system has been installed in the base camp. This system ensures that there is sufficient purified water available for staff members to use for drinking water and food preparation. To maintain the quality of water, the team conducts quarterly water quality monitoring, and the site doctor and HSE team perform hygiene inspections and audits according to the planned schedule. Regular service and maintenance are also scheduled and implemented to ensure that the RO system continues to function properly.

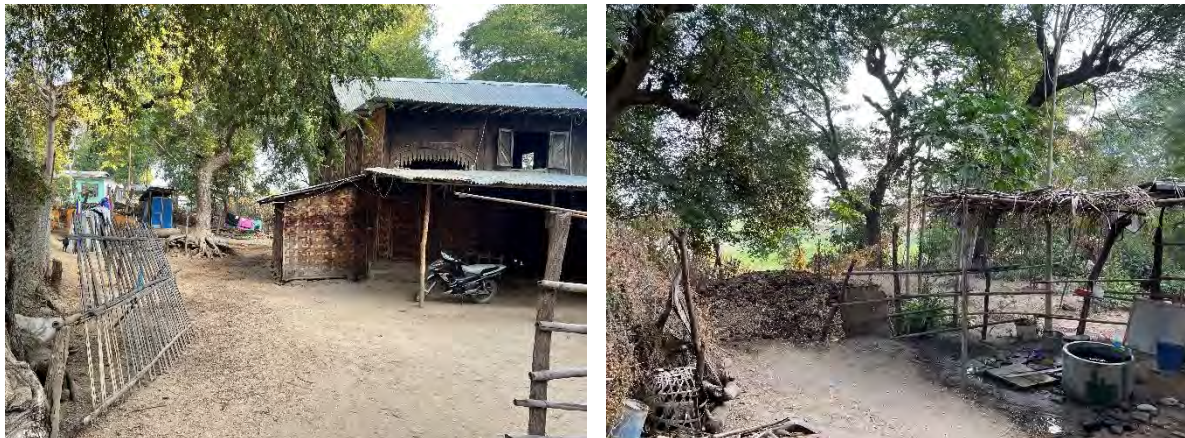
In July 2023, MPRL E&P conducted groundwater quality monitoring near well 132 (Ko Win Maung) and found that all parameters were within the Drinking Water Quality Standard (2019), except total dissolved solids, total coliforms, total fecal coliforms, manganese, and sulfate. The reasons of the TDS value higher may be the geological factors, waste disposal issues, etc. The presence of bacteria in tube well indicates microbial pollution mainly due to septic systems, farming of cows near the source of water. The high sulfate levels may be due to geological factors, human activities, and microbial activity. The owner of the tube-well did not use the water for drinking purposes, but instead used it for bathing, watering plants and washing.

Figure 53: Ko Win Maung Tube Well

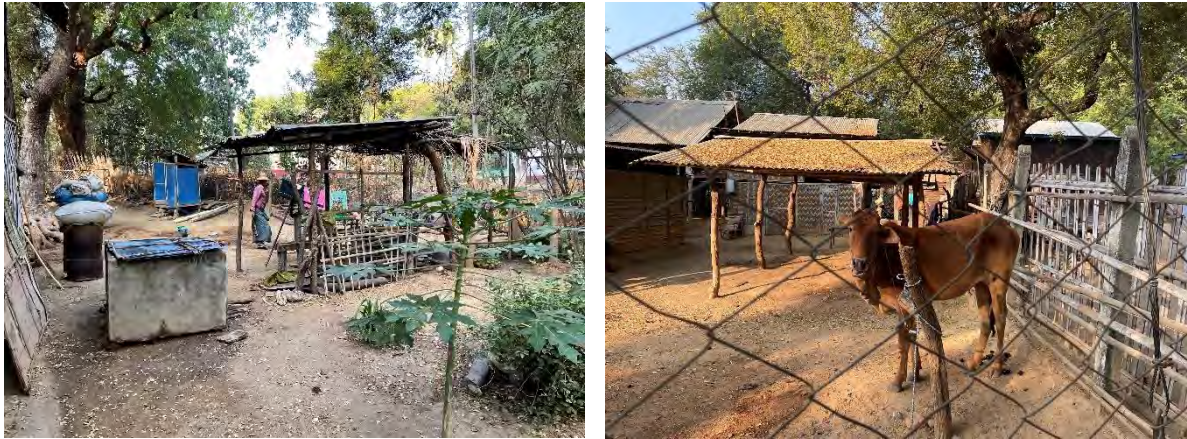
At the Ma Nyein Well, all the results were shown to be under the Drinking Water Quality Standard (2019), except for total dissolved solids and sulfate. The reasons of the TDS value higher may be the geological factors, waste disposal issues, etc. The high sulfate levels may be due to geological factors, human activities, and microbial activity. The tube well is approximately 20 feet deep and is mainly used for watering plants, washing, and bathing purposes.

Figure 54: Ma Nyein Tube Well

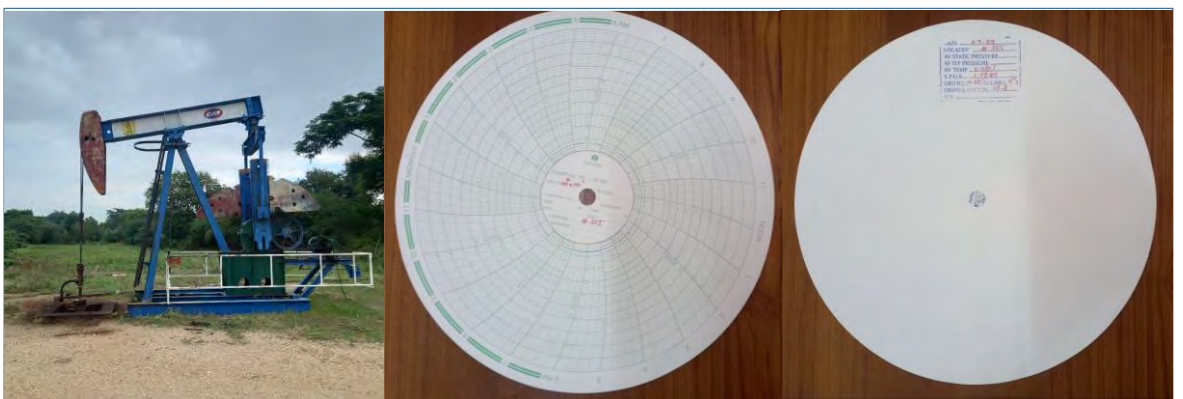
Gas Volume measurement (Orifice Meter) Well-298

Date : 06 July 2023, Gas Volume – 0 CFD
