Environmental Monitoring Report

for Redevelopment and
Enhanced Oil Recovery (EOR)
Programme

April 2023 ~ September 2023

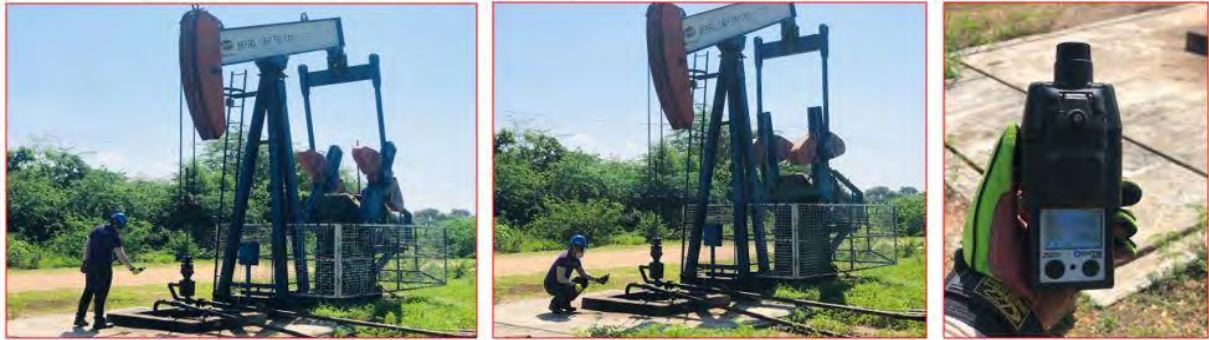
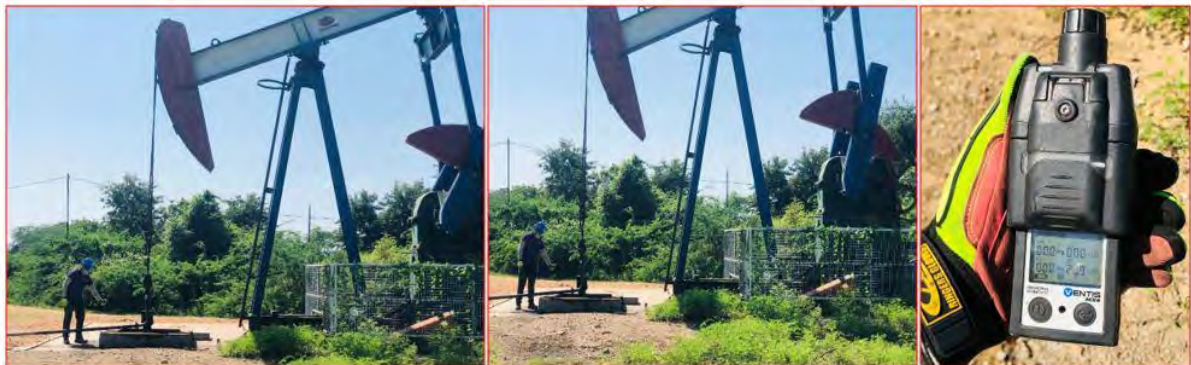
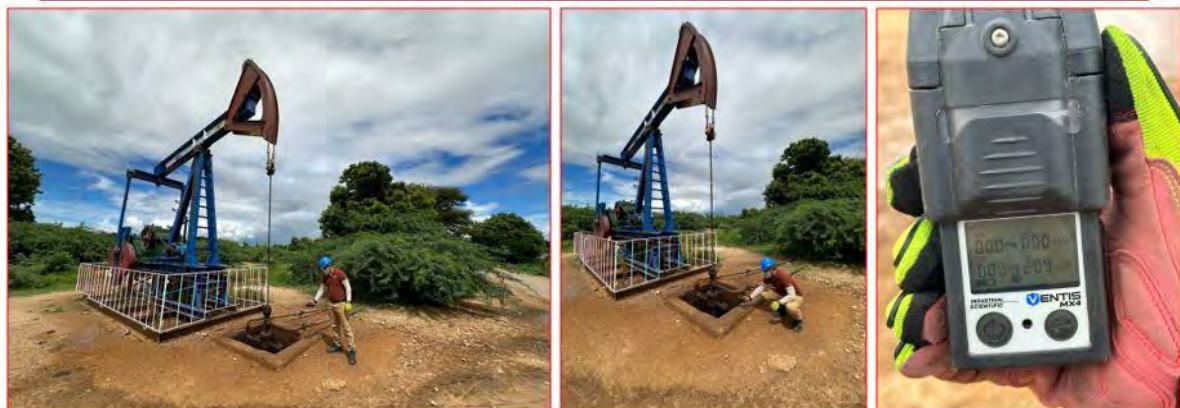
H₂S levels are monitored using an in-house portable gas detector (VENTIS MX4 Gas Detector), which has been calibrated as shown in Annex – 3 Equipment Calibration Certificate. This equipment can monitor four (4) parameters. As a result of monitoring, no H₂S was detected, and the results for each well are listed in the above Table 31.

Figure 56: H2S Monitoring Activities

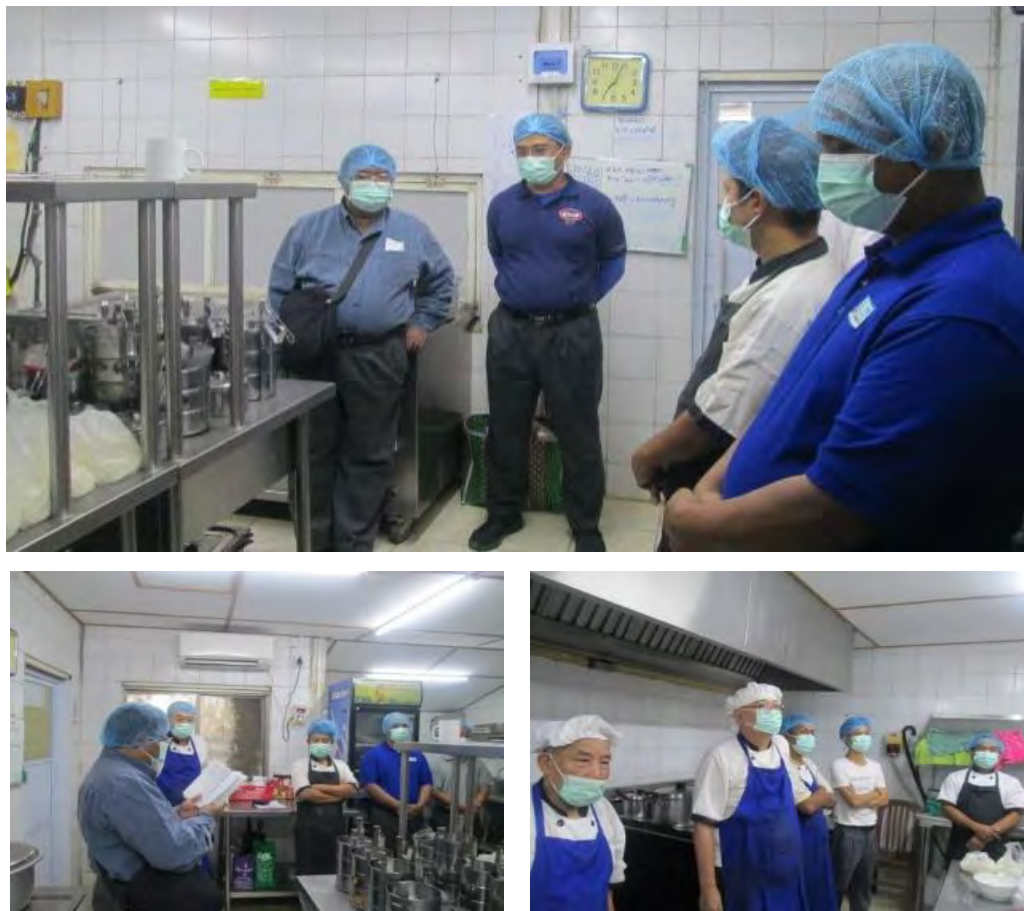
To guarantee the safe storage of refrigerated and frozen foods, maintain the personal hygiene of food handlers, ensure equipment cleanliness, and implement general food poisoning prevention measures, we conduct joint inspections of kitchens and food storage areas with the Field Team. During these inspections, certain equipment cleanliness and pest control issues have been identified as areas requiring improvement. Collaboratively, our contractor and field operation team rectified these issues and monitor the progress and completion accordingly.

Figure 58: Kitchen & Storage Weekly Regular Inspection and Pest Control

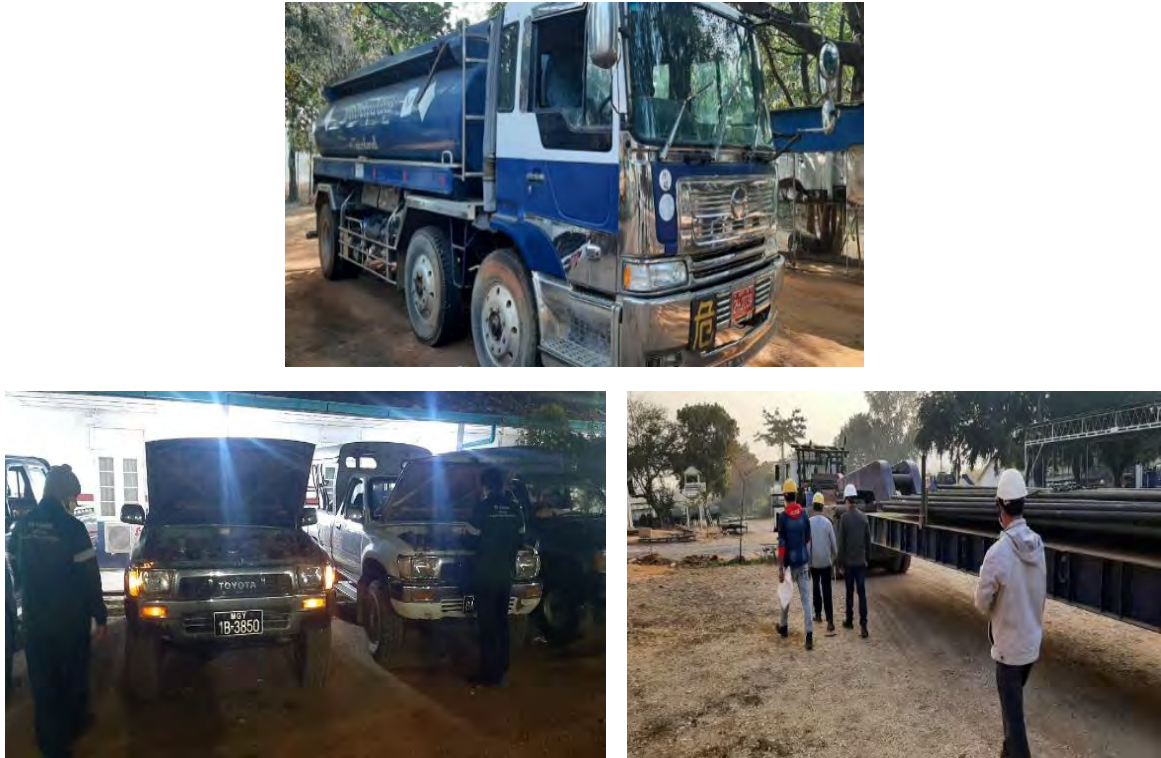
Figure 59: Vehicle and Workshop Safety Inspection in Mann Field

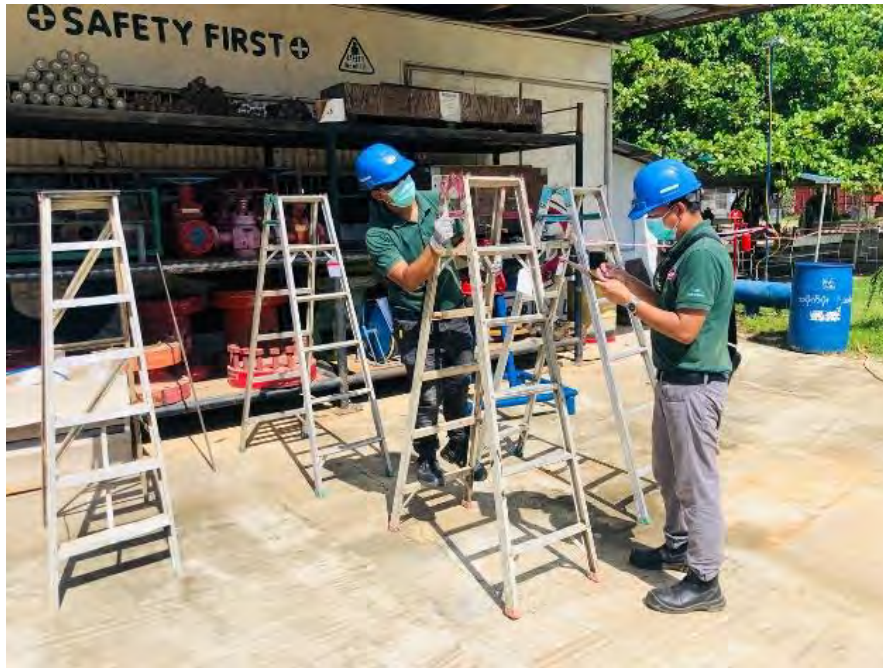
Figure 61: Ladder Inspection

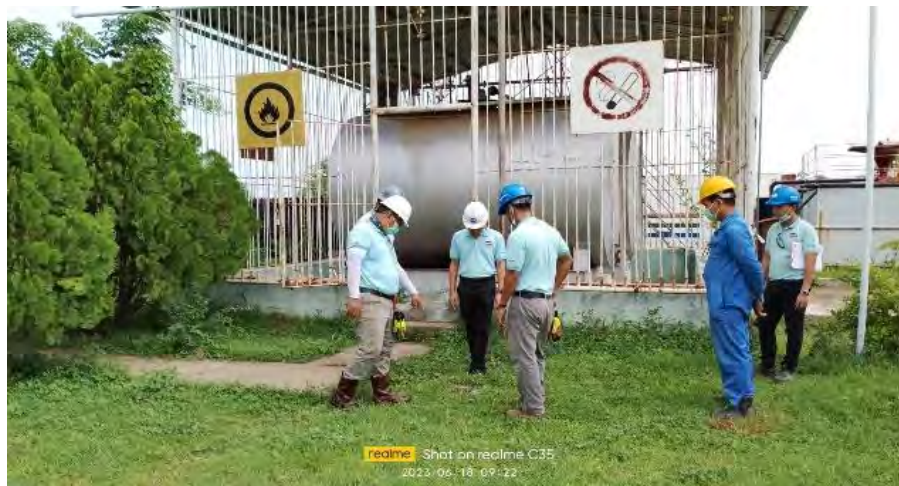
The Field Management and HSE team is currently engaged in hazard hunts to identify physical hazards, especially those associated with potential slip, trip, and fall risks, within various facility areas such as the workshop, downhole, GOCS-2, and the warehouse. We are actively reporting and addressing these hazards, some of which may not be immediately apparent during daily operations. This involves specifying necessary actions, assigning responsibilities, and setting completion dates.

**Fabricated step ladder for fuel storage tank.
(STF-hazards findings)**

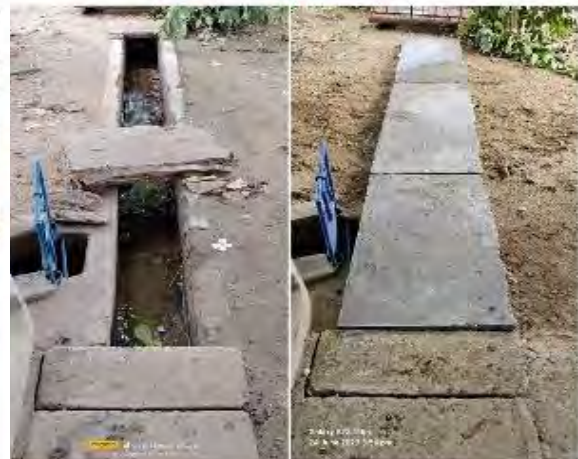
Figure 62: Hazard Hunts

**Concrete work for drain ditch covers.
(STF-hazards findings)**

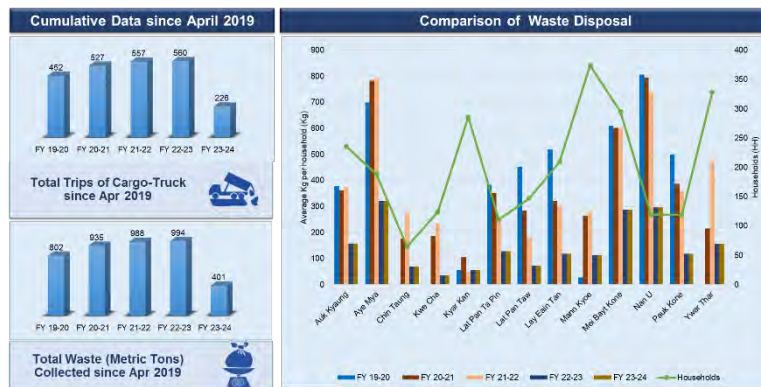
Figure 134: Comparison of Waste Disposal (Quarterly)

- Organized World Cleanup Day 2023 in Mann Field, and organized the cleanup events. In the celebration of World Cleanup Day 2023, three garbage dumps were cleared out together with the CSR Program, Mann Field Communities and Trash Hero Minbu and (48) metric tons of waste were successfully disposed to Minbu Township's municipal landfill site in 16 September 2023.

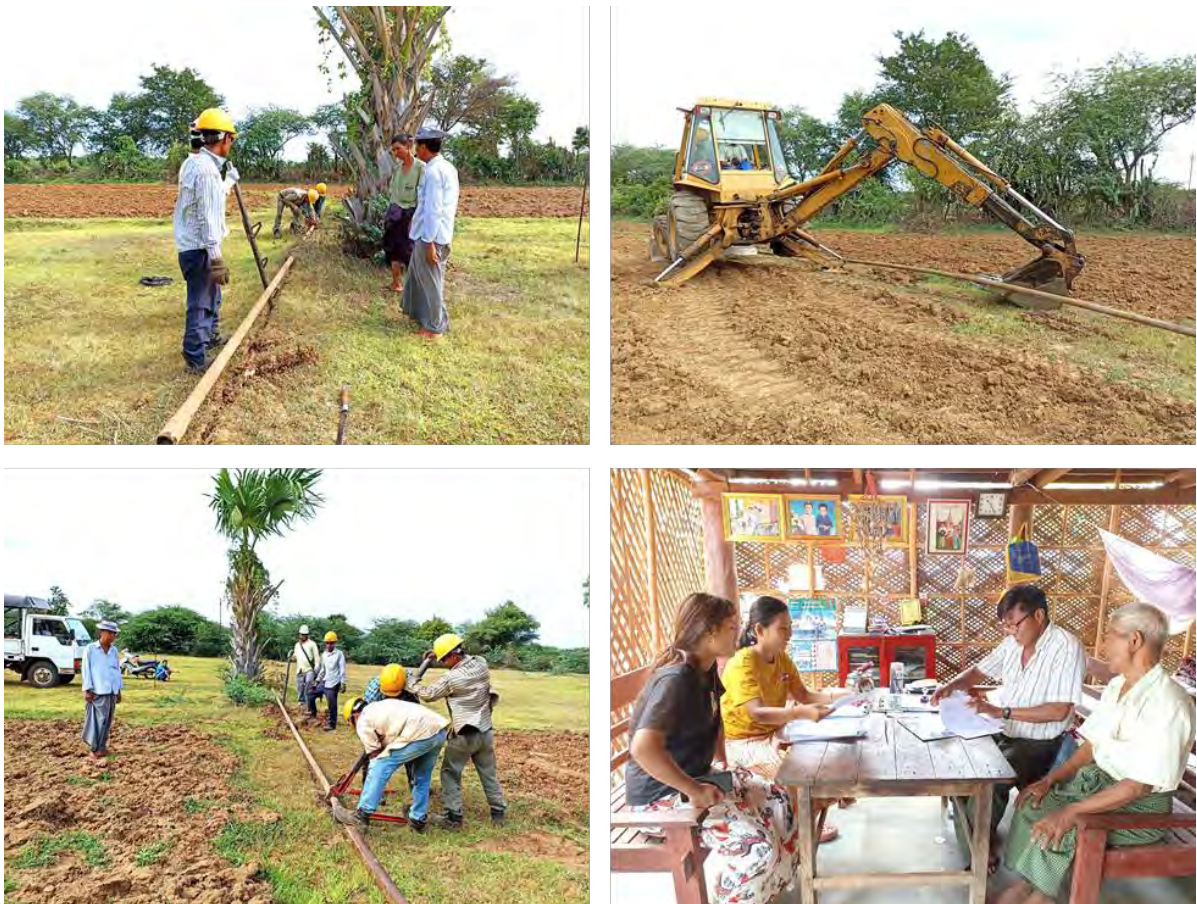
Figure 139: Addressing OGM Cases Submitted by Kyar Kan Villagers

- 4) On 11 July 2023, U Myint Aung from Kyar Kan Village reported an OGM case related to one electronic iron pole and one electronic wooden pole in his farmland leaning which can cause electronic hazards. The CSR Field Coordinator reported the case to MPRL E&P's Field Operations Team and MOGE. After inspecting the case, MOGE's Electrical Department fixed the case by repairing the iron pole and replacing the wooden pole with a new iron pole. The complainant was satisfied with the process and outcome.

CSR Field Coordinator reported the case to MPRL E&P's Field Operations Team. After inspecting the case, the MPRL E&P's Field Operations Team fixed the case by removing the unused old pipeline. The complainant was satisfied with the process and outcome.

- 6) On 13 September 2023, U Han Thaung from Kyar Kan Village reported an OGM case related to an electronic pole in his farmland falling down which can cause electronic hazards. He informed the case to MPRL E&P's CSR Team and requested to inspect and repair it as necessary. After inspecting the case, the MOGE Electrical Department fixed the case by repairing the electronic pole. The case was closed on 14 September 2023 and the complainant was satisfied with the process and the outcome.
