Environmental Monitoring Report

for Redevelopment and
Enhanced Oil Recovery (EOR)
Programme

October 2025 ~ March 2026

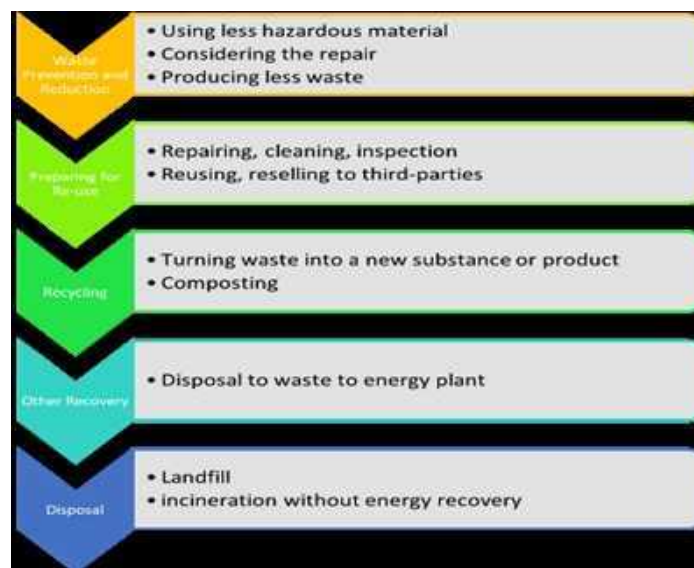
Figure 2: Waste Management Process

- Segregating waste into hazardous, general and recyclable categories using suitably labeled bins,
- Transporting bins/drums to approved disposal locations with the waste type clearly labeled on each one,
- Including each waste bin/drum sent on the backload manifest,
- Recording waste transportation in the waste database.

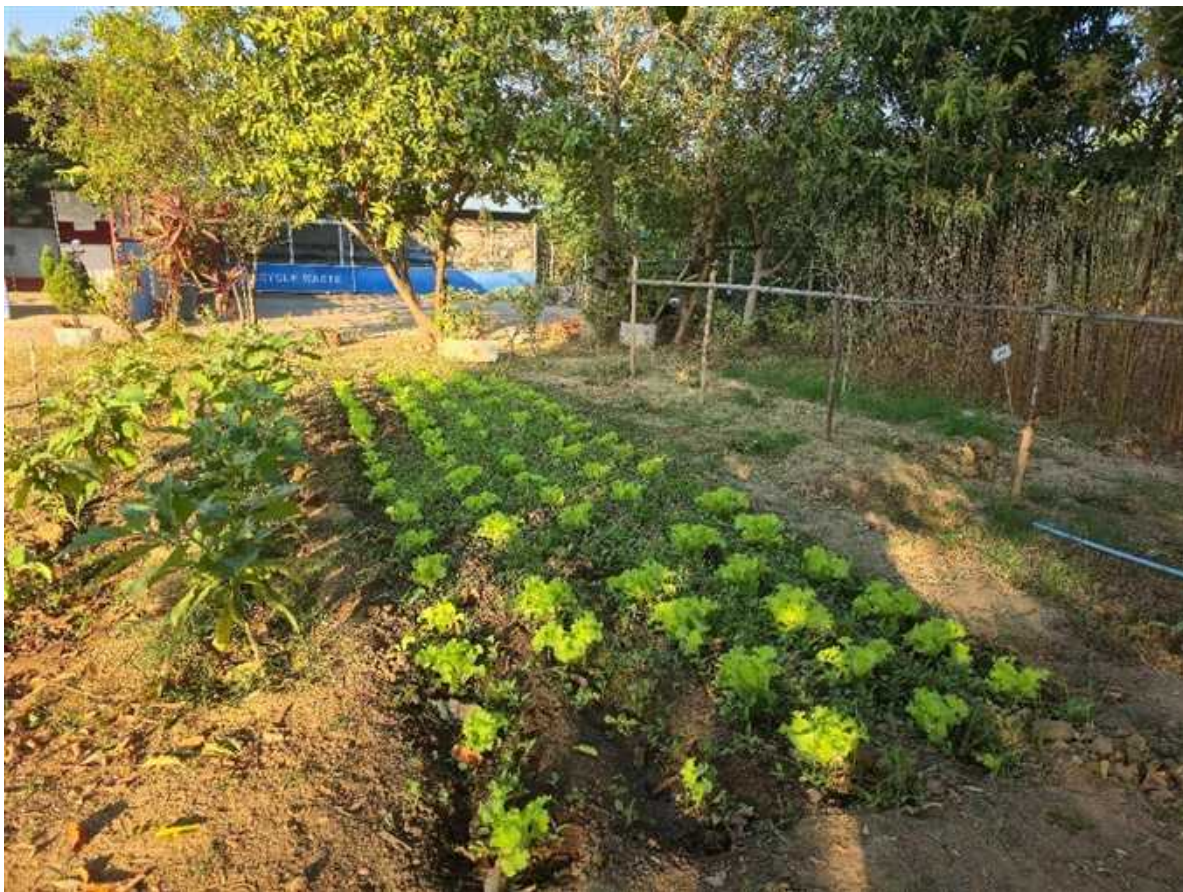
Figure 4: Vegetation Field with Composting of Food Waste at WMC

Based on our self-monitoring records spanning six months from October 2025 to March 2026, the composting process has yielded approximately 1,380 kg of compost.

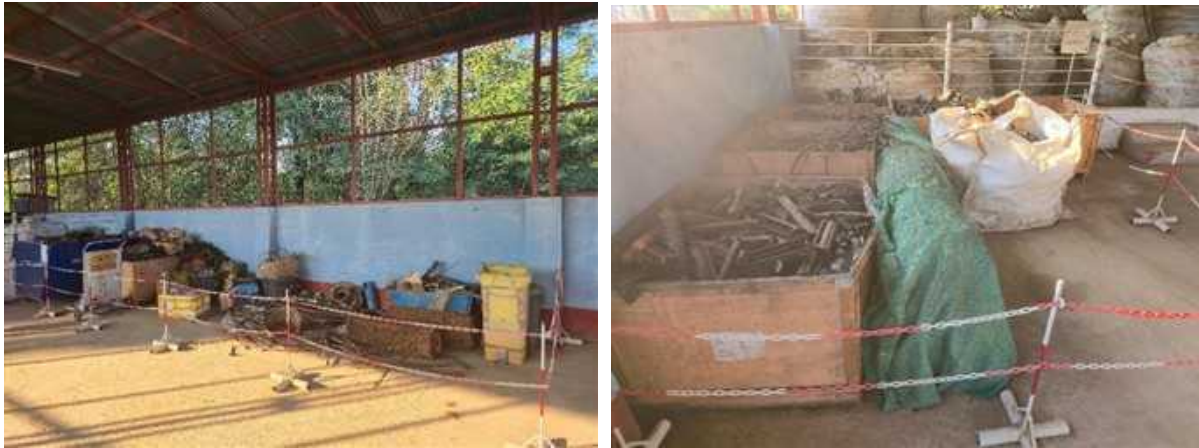
Figure 5: Segregated Recycle Waste at WMC

General Waste is collected from all areas within the Mann Field Operations and temporarily stored at the Waste Management Compound. Waste collection is carried out periodically every week using Jumbo big bags to reduce plastic bag usage, which

can be reused multiple times. Additionally, the plastic bags used in the waste bins are also reused, except for the organic waste bin.

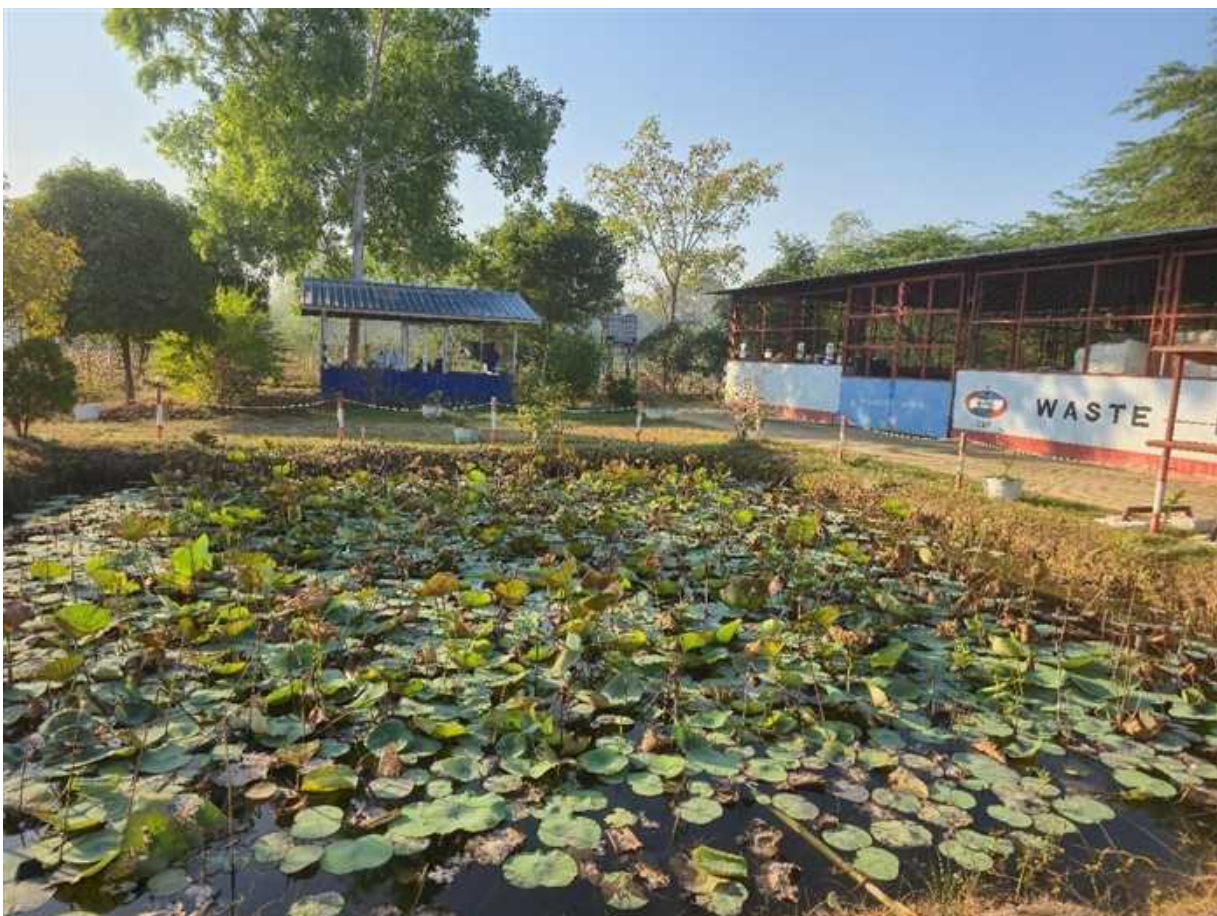
Figure 6: Waste Management Compound

After being re-sorted, packed and stored in the recycle waste storage area, the recycle materials are disposed of by an authorized third party.

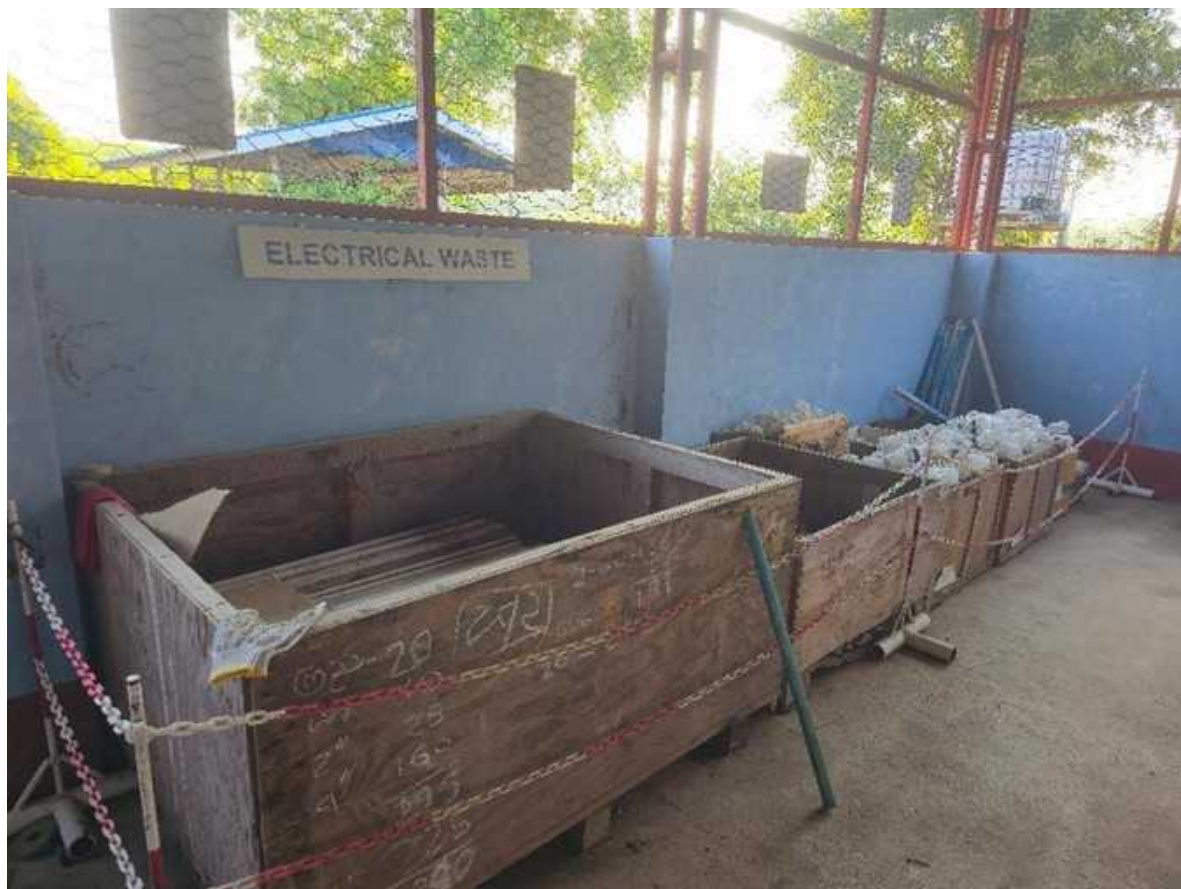
Figure 7: E-Waste Stored at WMC

From October 2025 to March 2026, a total of 5 kg of hazardous waste is collected from all work-related areas and is properly stored at the Waste Management Compound. The dry sludge/ produced sand is temporarily stored at the Waste Management Compound, while the wet sludge is stored at the Sludge Management Compound.

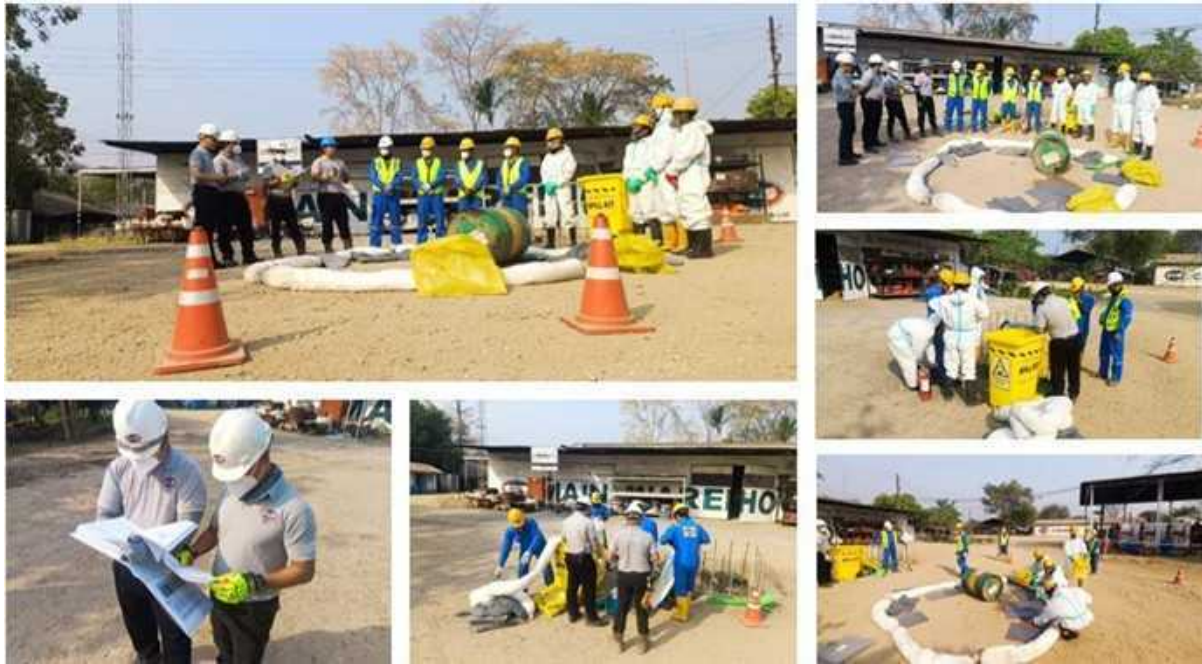
Figure 12: Spill Drill (Chemical) at Warehouse

A chemical spill drill exercise was conducted at Warehouse on 04 March 2026. The objective of the exercise was to test emergency preparedness, evaluate the effectiveness of the oil spill response plan, and ensure personnel readiness in the event of an actual spill incident. The drill involved the mobilization of response teams, deployment of spill containment equipment, and implementation of safety procedures.

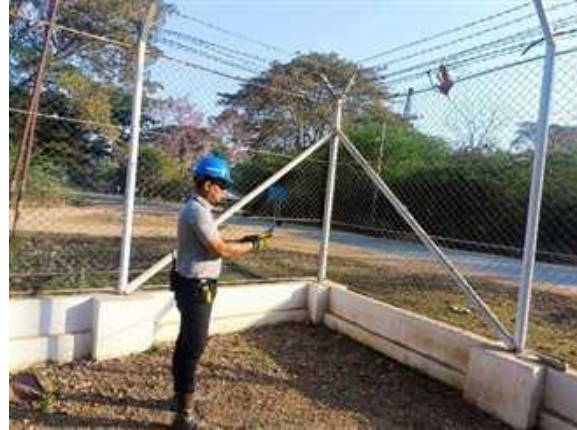
Figure 23: Noise Metering near MPRL E&P's Mann Field Base Camp

P-70's and P-82's Noise Effect to Base Camp

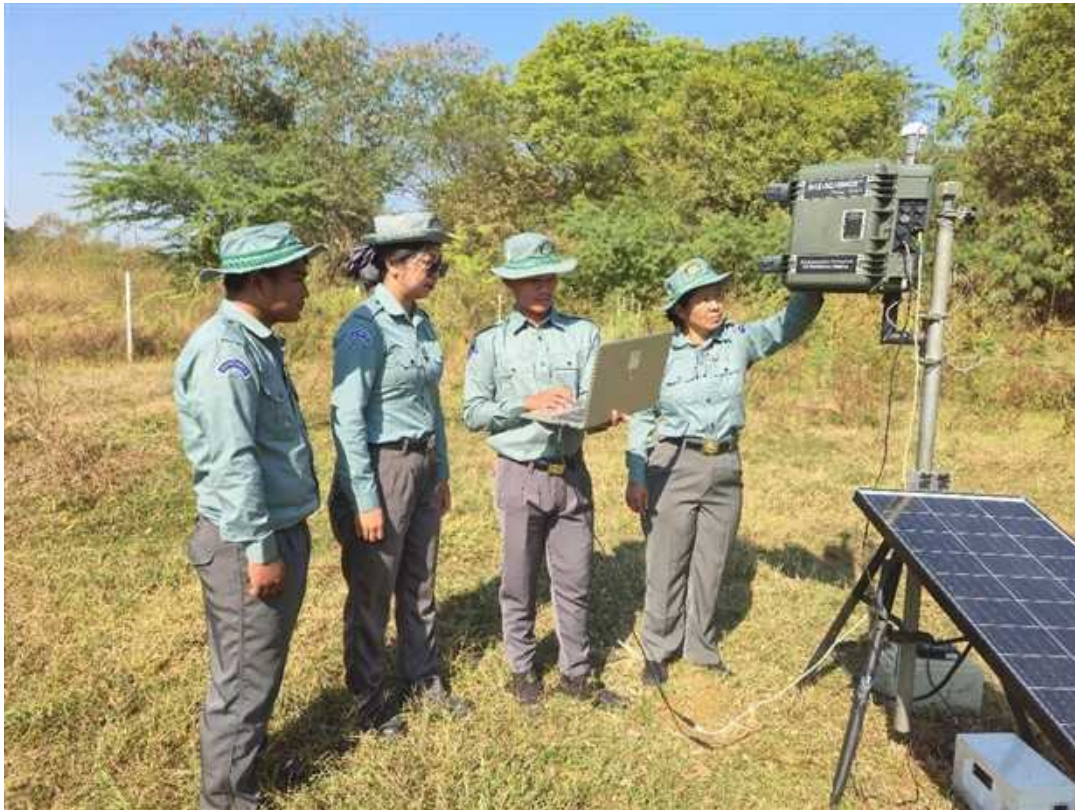
Figure 30: Air and Noise Quality Monitoring at Z3AQN

With the regional ECD (Magway) team, we conducted air and noise quality monitoring at Z3AQN and Z4AQN, soil quality monitoring at Z3S1, Z3S2, Z4S1, and Z4S2.

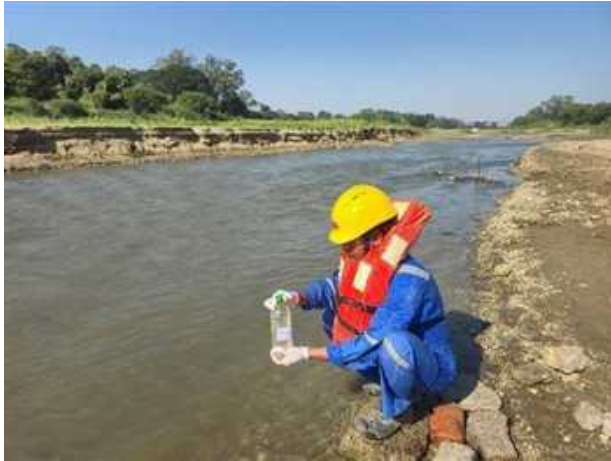
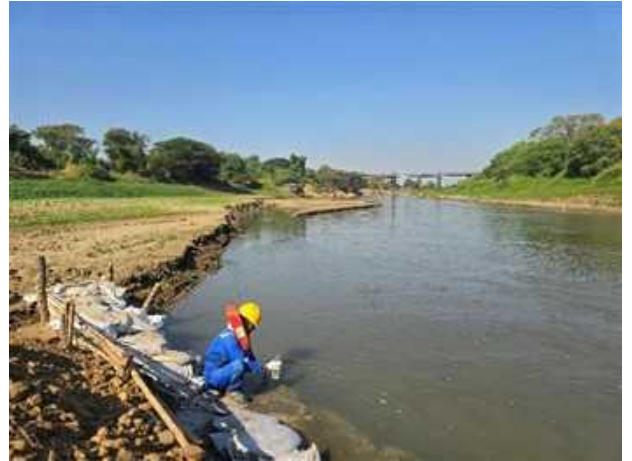
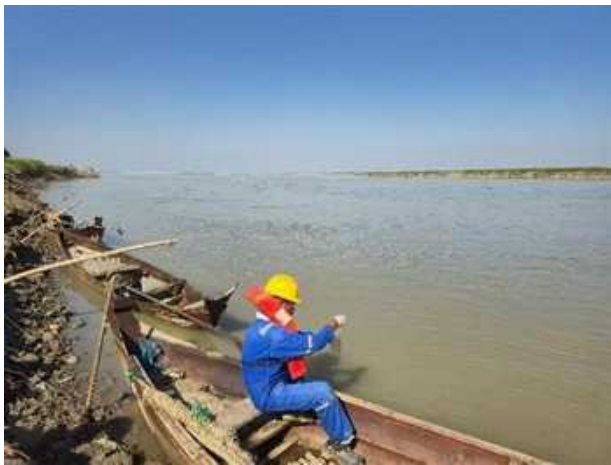
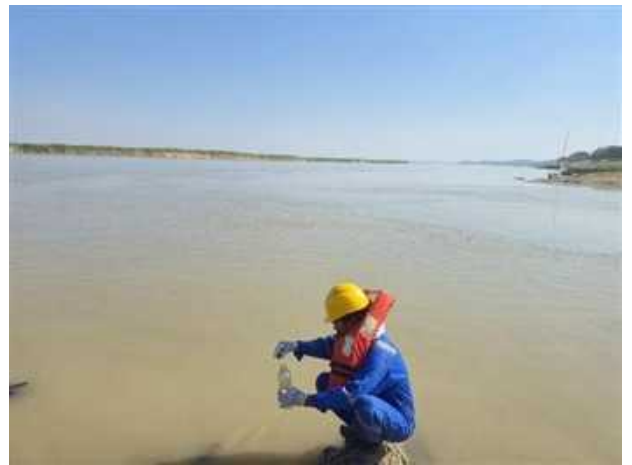
Figure 35: Surface Water Quality Monitoring at Z3SW1, Z3SW2, Z4SW1, and Z4SW2

By the collected water samples measuring results, all are under NEQEG (2015) standards and NSWQS except for the total suspended solids parameter. The possible reasons of exceeding guideline values may be from agriculture, mining and quarrying, deforestation, industrial discharges, etc.

The monitoring results of surface water in January 2026 as shown in Table 19.

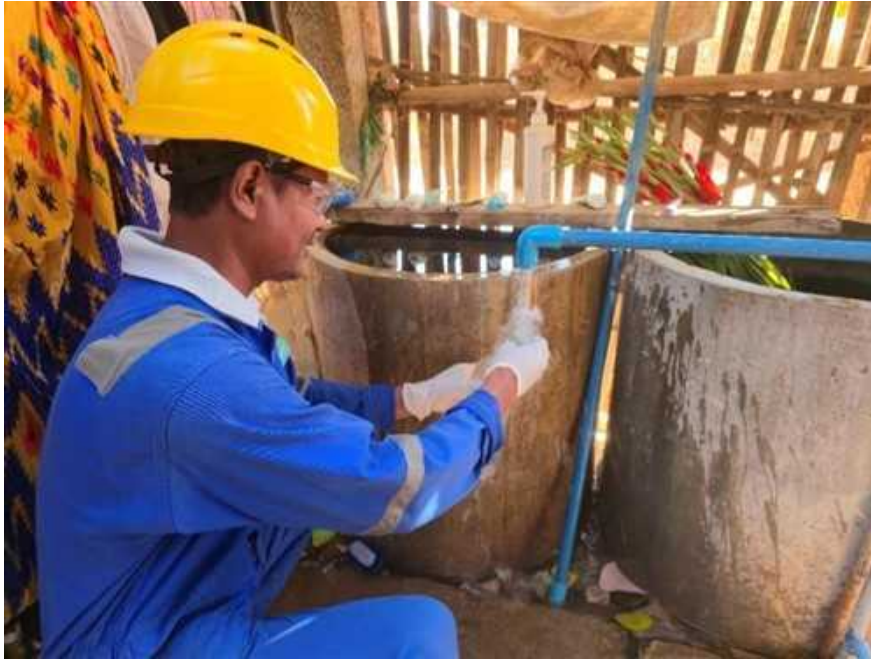
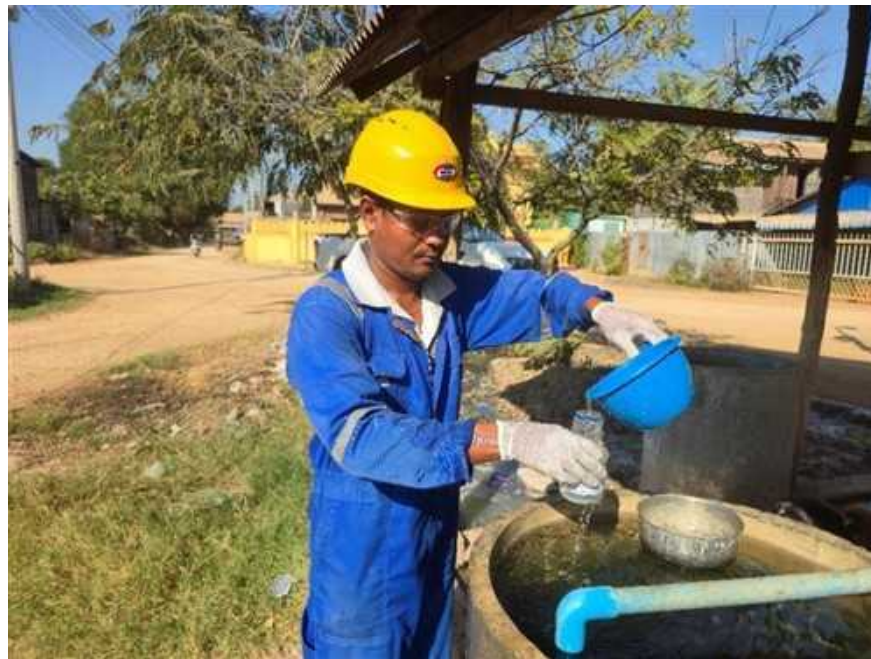
Figure 37: Groundwater Sampling at Z3GW1 and Z4GW2

The results of groundwater quality monitoring are summarized in Table 21.

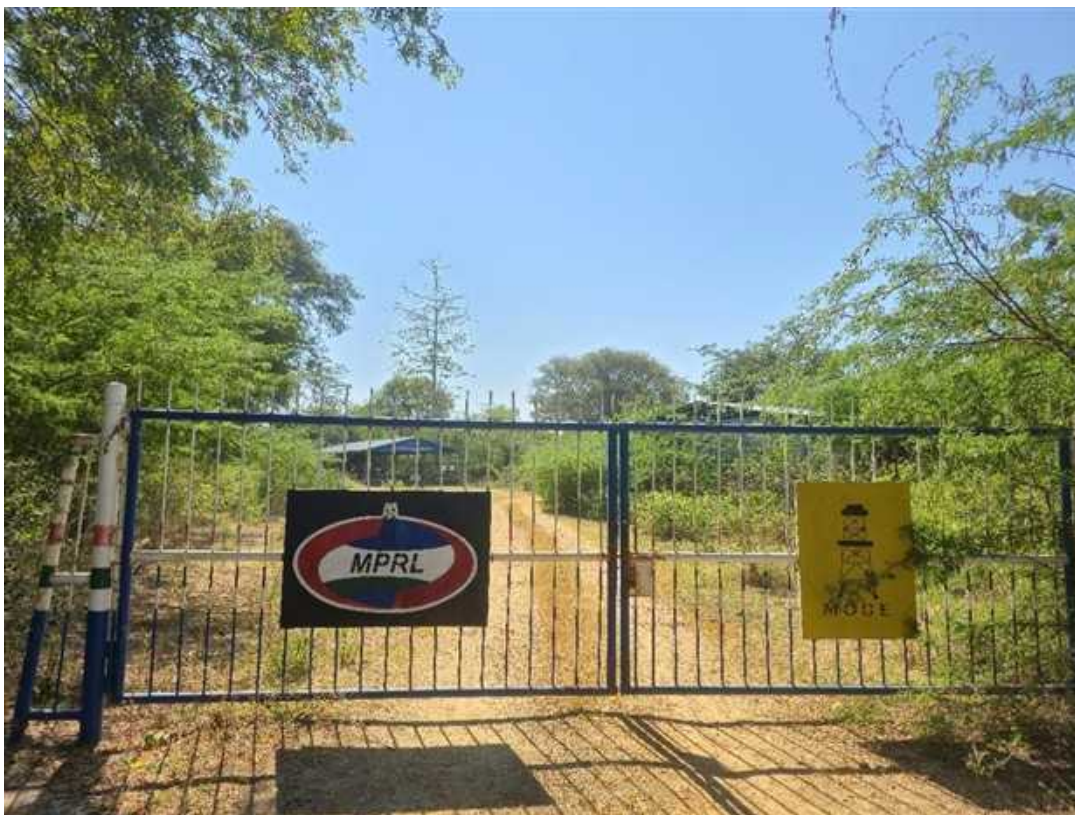
Figure 38: Sludge Management Compound (SMC)

Dried sludge, weighing approximately 167 tons (estimated weight), is currently being stored temporarily at the Waste Management Compound and at the Sludge Management Compound (extended dried sludge storage shed).

Currently, all the collected wet sludge is being stored properly in three concrete pits to ensure compliance with the NEQEG guideline levels for Onshore Oil and Gas Development. Any hazardous waste will be disposed of according to the commitments made in the ECC.

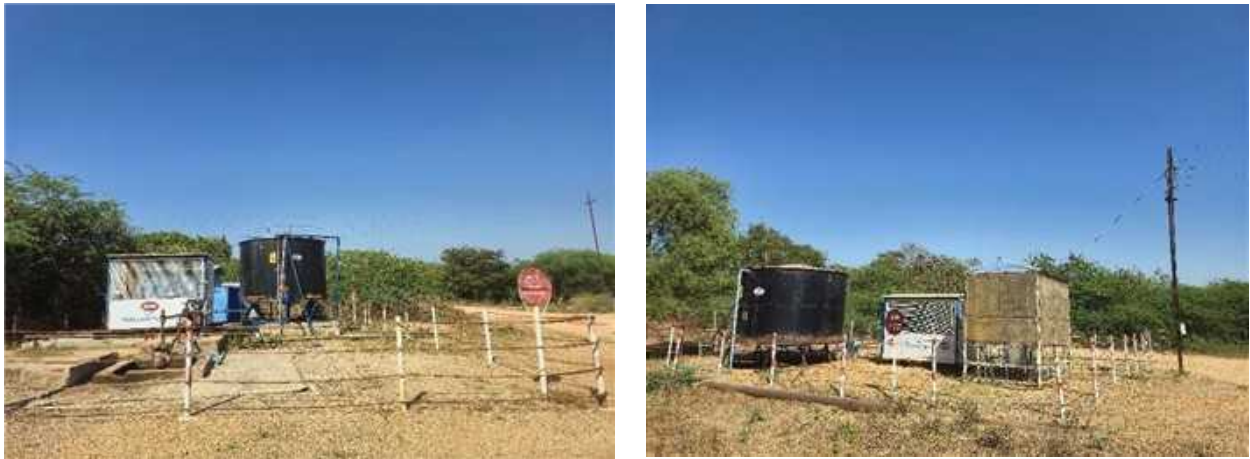
Figure 39: Produced Water Injection into Shut-in Wells

MPRL E&P is undertaking to inject all produced water (100%) into the shut-in wells by using 9 units of injection pumps to meet guideline levels in NEQEG for Onshore Oil and Gas Development.

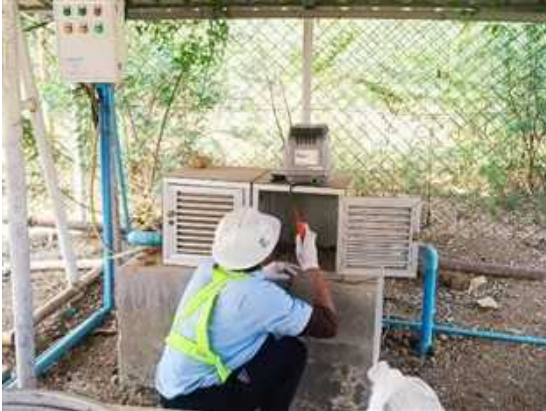
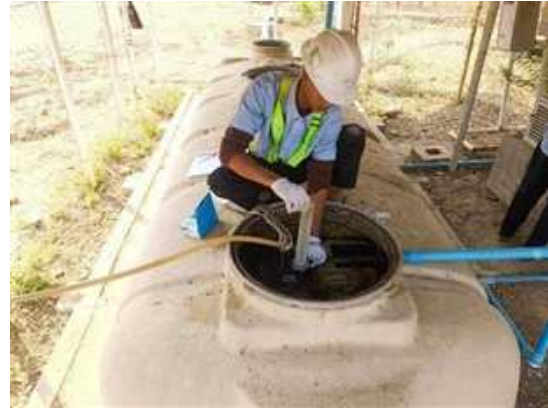
Figure 42: Regular Maintenance of Bio-filter by Third-party

During the month of January 2026, we collected water samples from the bio-filter treated system and sent them to ALARM and ISO Tech lab for testing and found that the results are under the NEQEG guideline except total phosphorous and it may be the biological or chemical balance required to "trap" the phosphorus has been disrupted. It is periodically serviced and maintained by the service provider quarterly basis.

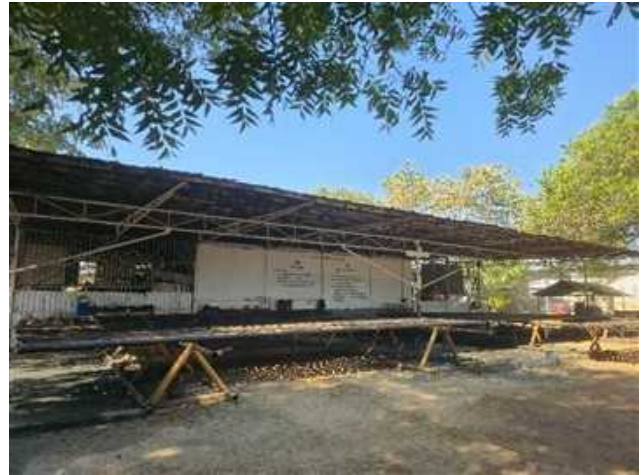
Figure 43: Warehouse Tubular Section

At the Mann Field warehouse, the team previously conducted hydro tests on tubing in a designated pressure test area. However, the field team has since minimized water usage by implementing a recycling system that uses zero discharge recycled water for these tests.

The hydro-test water monitoring schedule was carried out during the month of January 2026. The monitoring results revealed that all parameters complied with the NEQEG guidelines except for BOD5 value and Total Suspended Solid value. BOD5 value exceeding may be many reasons such as using of organic additives in hydrotesting, residual contaminants, source of water quality, etc. Total suspended solid value may high due to rust, scale, metal oxides, or sediment from aging pipelines, introducing particulate matter into the wastewater.

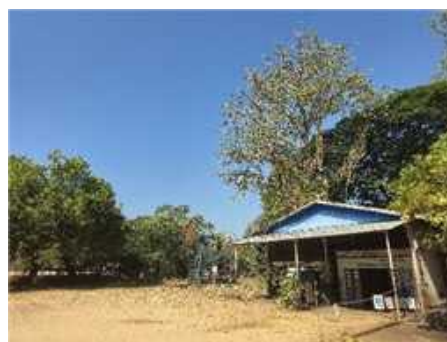
Figure 45: Down-hole Workshop

In January 2026, we monitored the water samples from a zero-discharge tank of Down-hole workshop, and all of them complied with the NEQEG, except for Chlorine (total residual), Chromium (Hexavalent), and phenols. The types of activities conducted in the workshop can have a significant impact on water quality.

The exceeding parameters may be due to its use in corrosion inhibitors, plating processes, and certain types of drilling fluids. The water used in the

daily operation of the down-hole workshop was collected in a concrete tank via a drain line and reused for recycling, thus avoiding discharge to the environment.

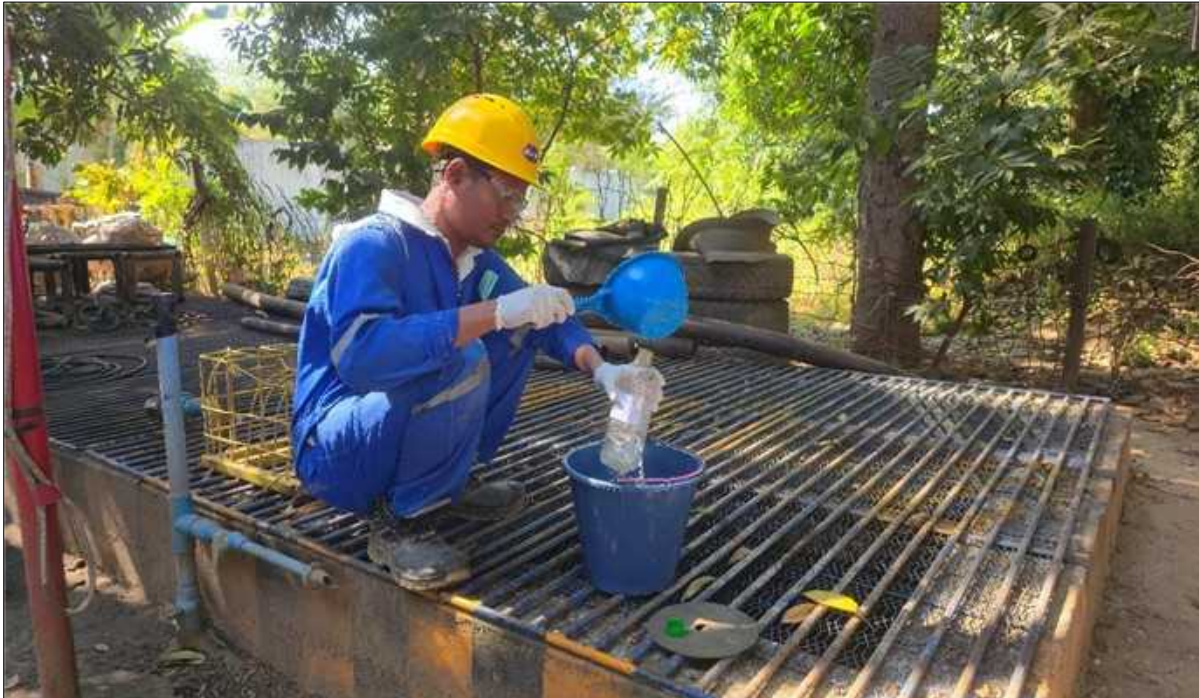
Figure 46: Water Sample Collection at Mechanical Workshop

Vehicles and machine parts undergo maintenance and repair work at the mechanical workshop, and the water used in the workshop's daily operation is collected in a concrete tank and reused.

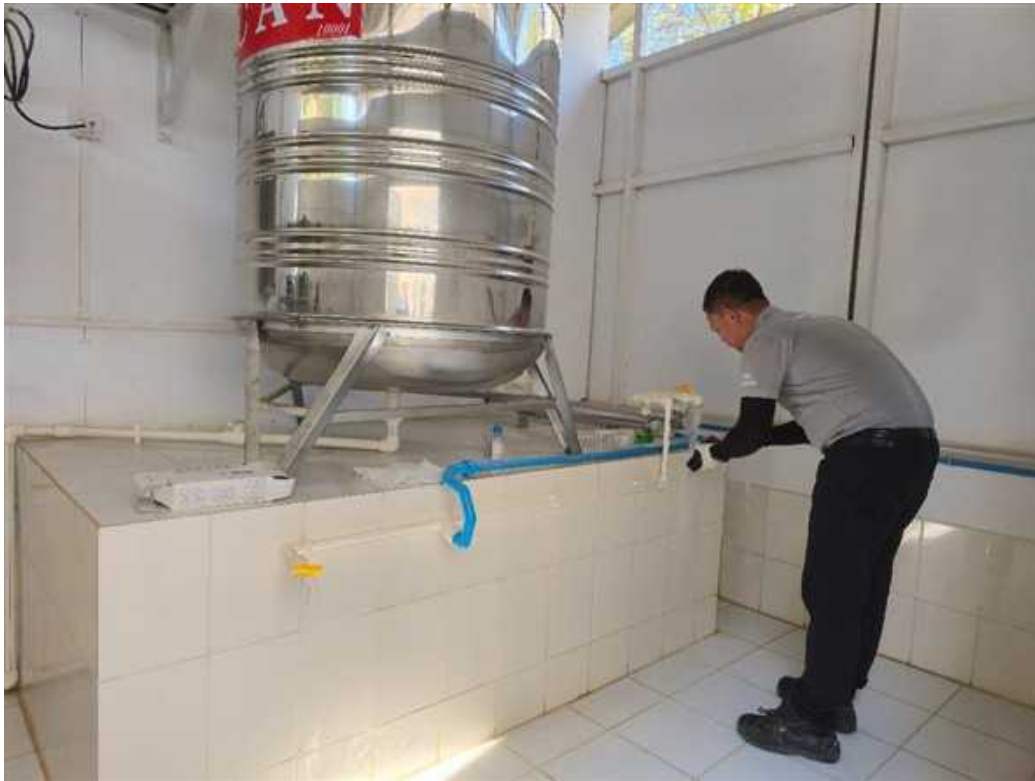
Figure 47: Collection of Drinking Water Sample from RO Drinking Water System

Access to safe drinking water is crucial for everyone's wellbeing, which is why a Reverse Osmosis (RO) drinking water system has been installed in the base camp. This system ensures that there is sufficient purified water available for staff members to use for drinking water and food preparation. To maintain the quality of water, the team conducts biannually water quality monitoring, and the site doctor and HSE team perform hygiene inspections and audits according to the planned schedule. Regular service and maintenance are also scheduled and implemented to ensure that the RO system continues to function properly.

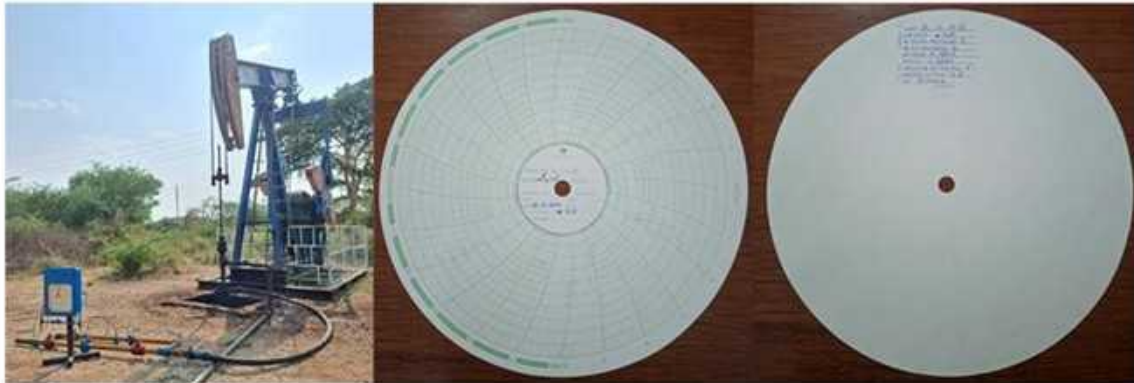
Gas Volume Measurement (Orifice Meter) Well-218

Date : 08 Oct 2025, Gas Volume – 0 MMCFD

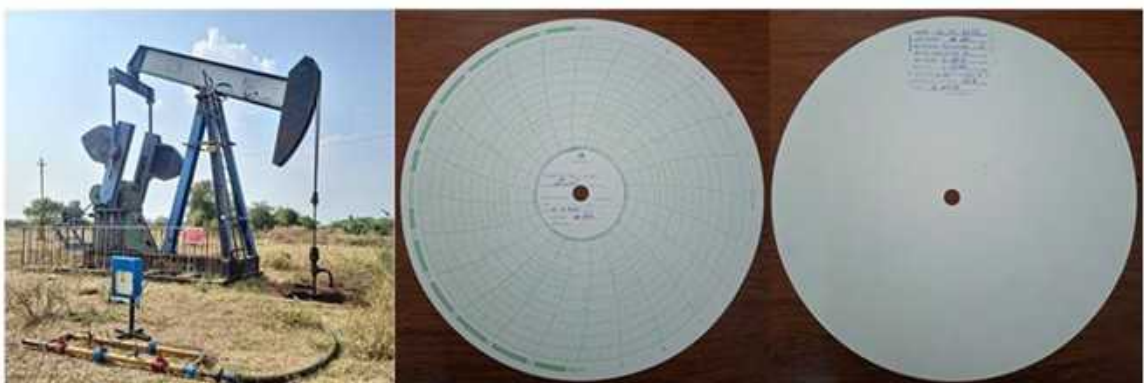
Gas Volume Measurement (Orifice Meter) Well-189

Date : 10 Dec 2025, Gas Volume – 0 MMCFD

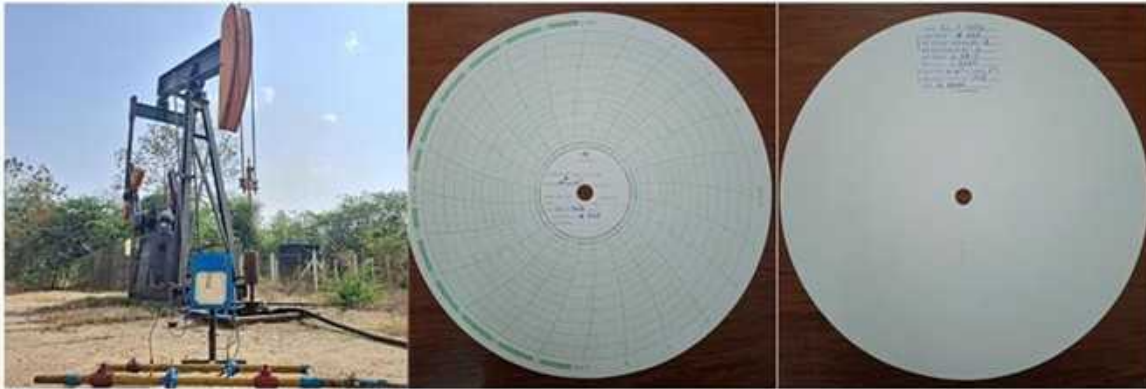
Gas Volume Measurement (Orifice Meter) Well-338

Date : 21 Jan 2026, Gas Volume – 0 MMCFD

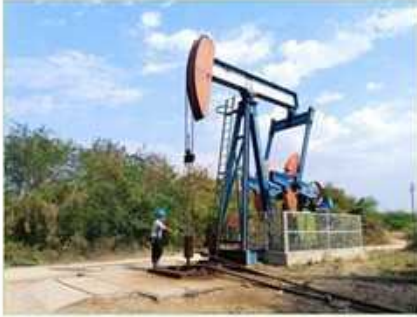
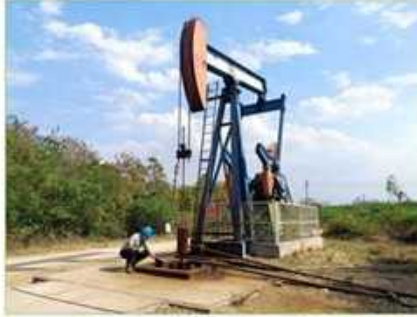
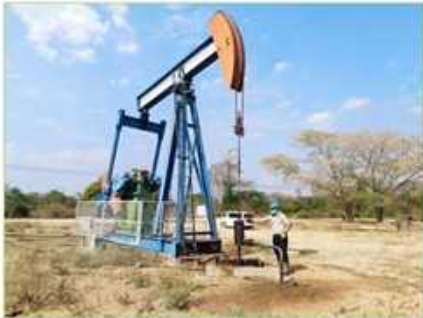
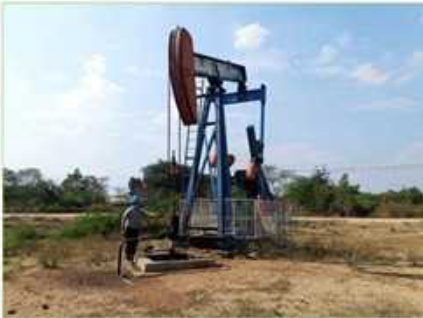
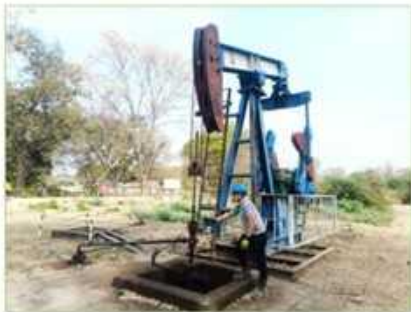
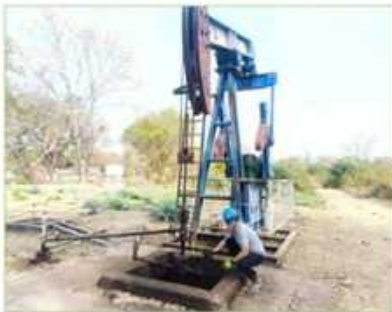
*Figure 51: H₂S Monitoring Activities*

H₂S levels are monitored using an in-house portable gas detector (VENTIS MX4 Gas Detector), which has been calibrated periodically as per plan. This equipment can monitor four (4) parameters. As a result of monitoring, no H₂S was detected, and the results for each well are listed in the above Table 30.

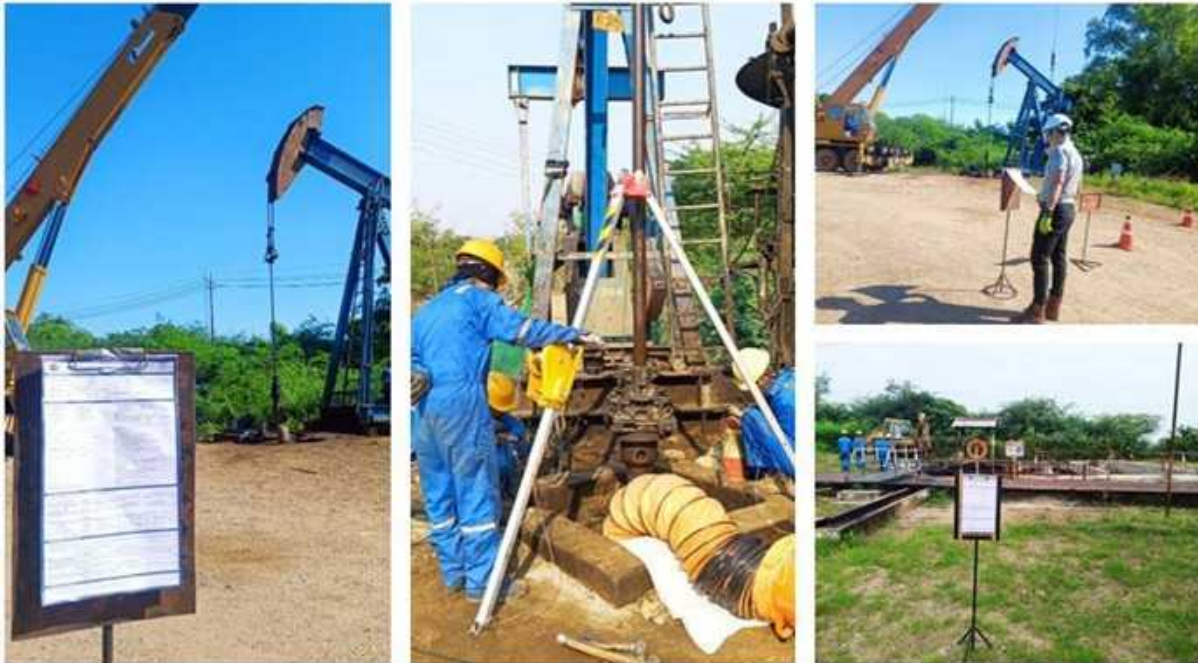
Figure 53: Permit to Work (PTW) Audit

Regular Permit to Work (PTW) audits are conducted utilizing a detailed checklist to ensure that all hazardous work is managed safely adheres to established procedures and that safety measures are thoroughly documented and implemented.

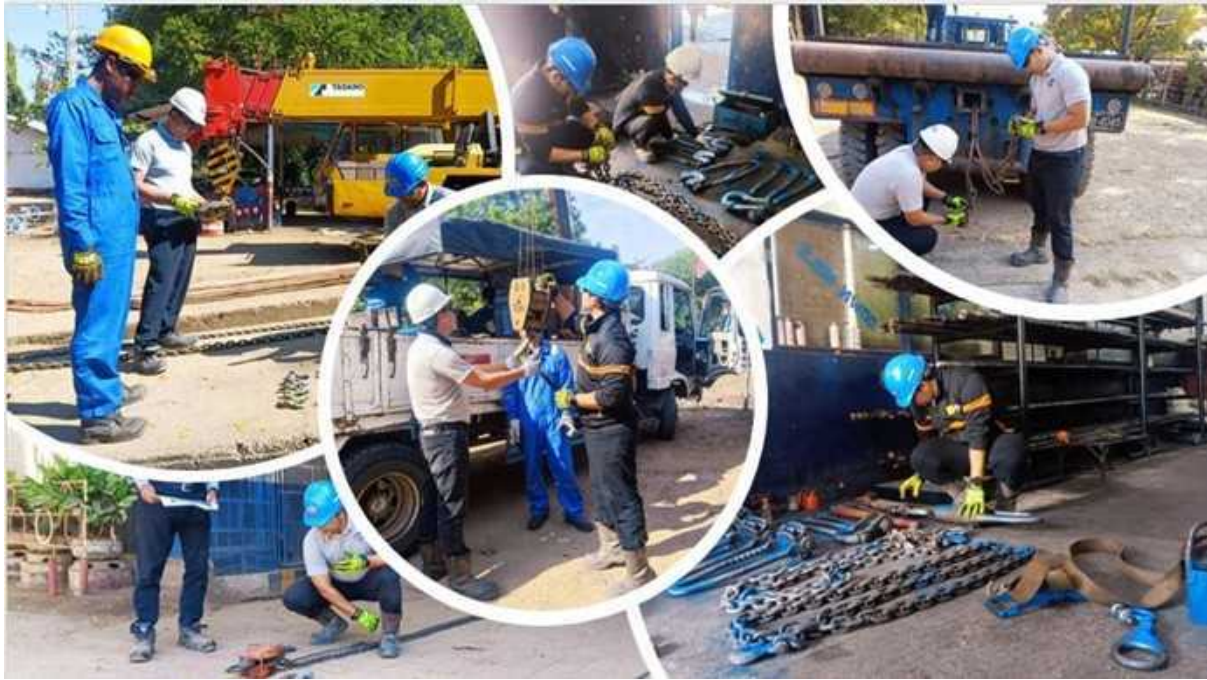
Figure 54: Lifting Gear, Hoisting & Handling Equipment NDT Inspection and Color Coding

To prevent incidents and ensure the reliability of lifting operations, a thorough inspection of all lifting gear, hoisting, and handling equipment was carried out.

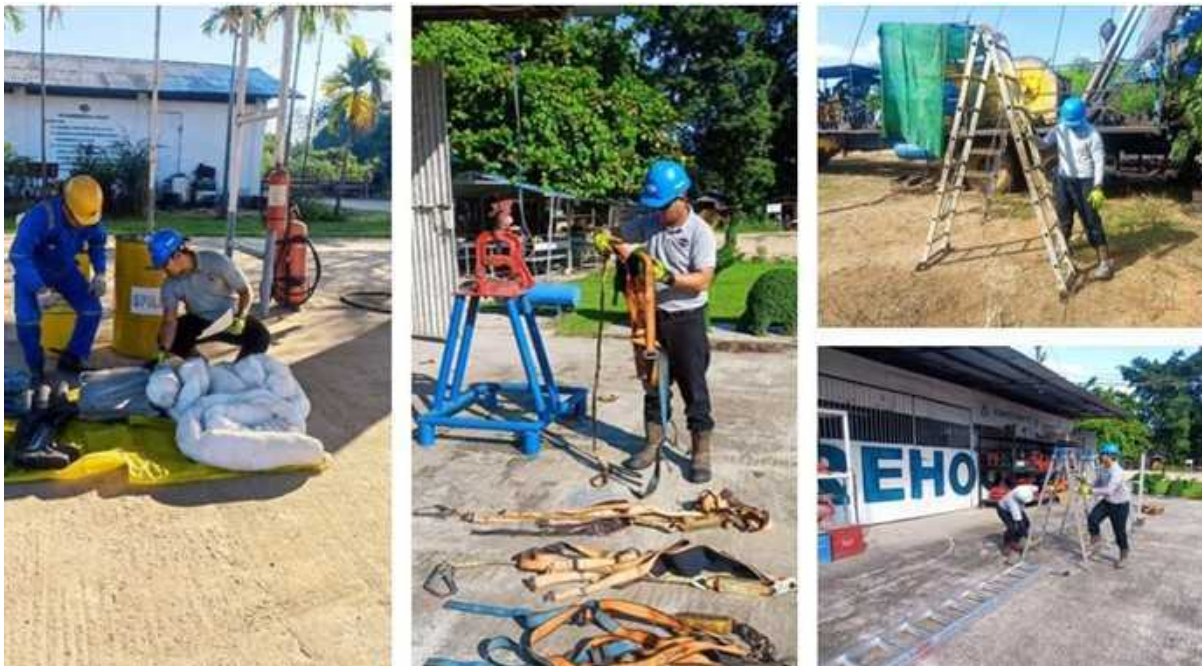
Figure 57: Spill Kit, Ladder and Safety Harness Inspection

As part of the organization's ongoing Slip, Trip & Fall and Working at Height Hazards Prevention program, an inspection of ladders and safety harnesses was carried out. The objective was to ensure the reliability of equipment and compliance with safety standards to minimize risks associated with working at height.

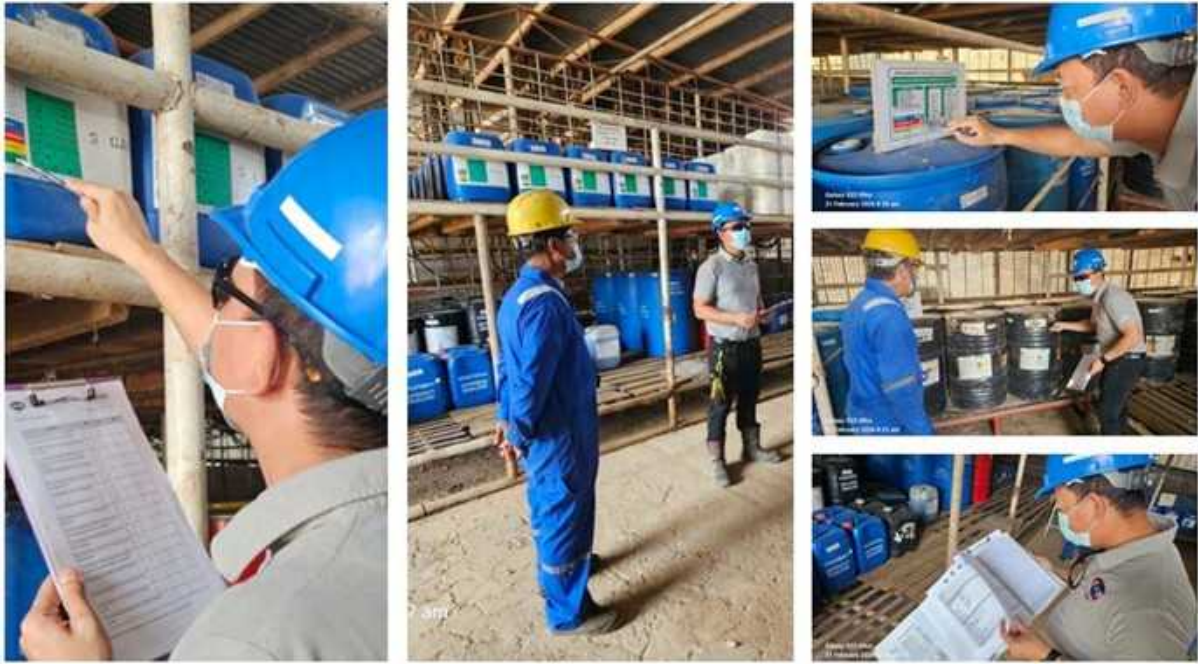
Figure 62: Inspection for Safe Chemical Storage

To maintain safe storage practices and ensure compliance with company HSE standards, an inspection of chemical storage was conducted at the KCL Warehouse and Container. The inspection aimed to identify potential risks, verify the condition of storage materials, and ensure the overall safety and cleanliness of the storage area.

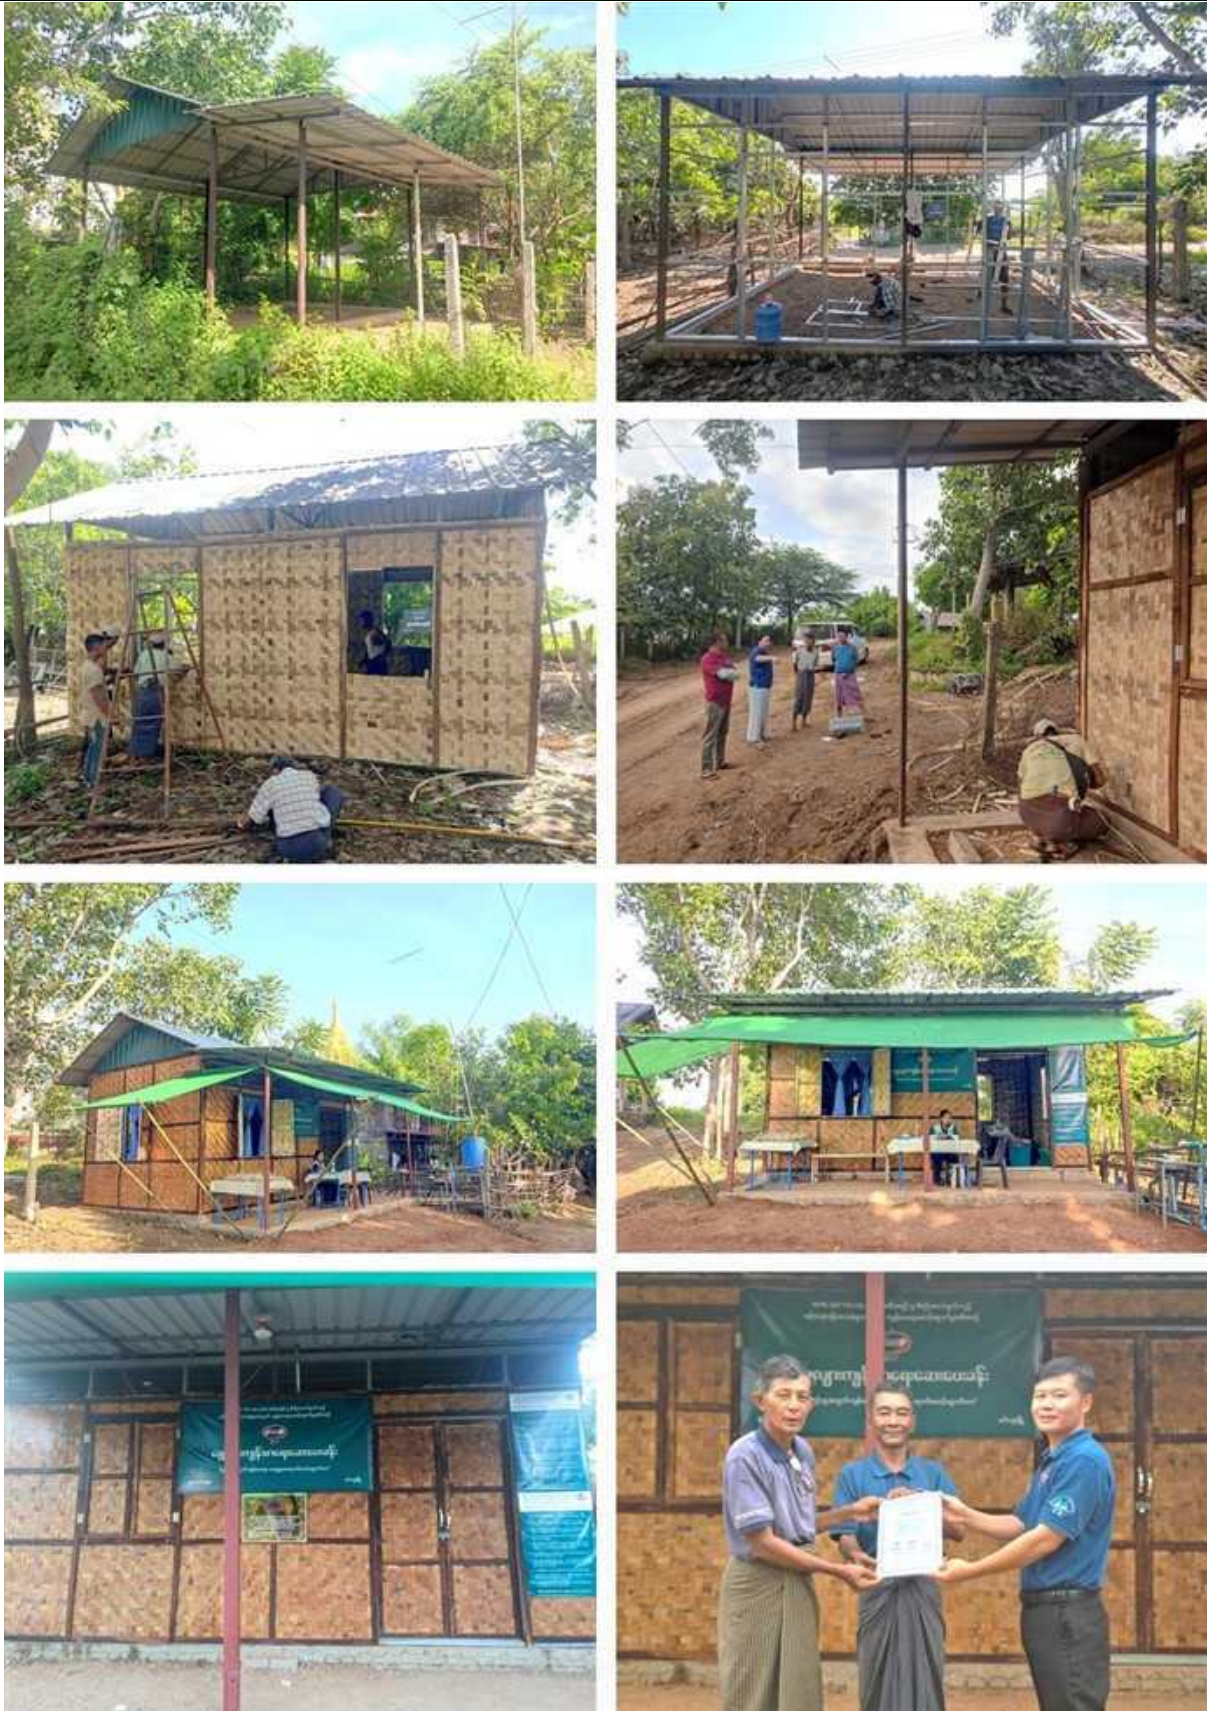
Figure 67: Completing the Construction of a Bamboo-Woven Structure at the Former Library Site in Ywar Thar Village
