Environmental Monitoring Report

for Redevelopment and
Enhanced Oil Recovery (EOR)
Programme

October 2025 ~ March 2026

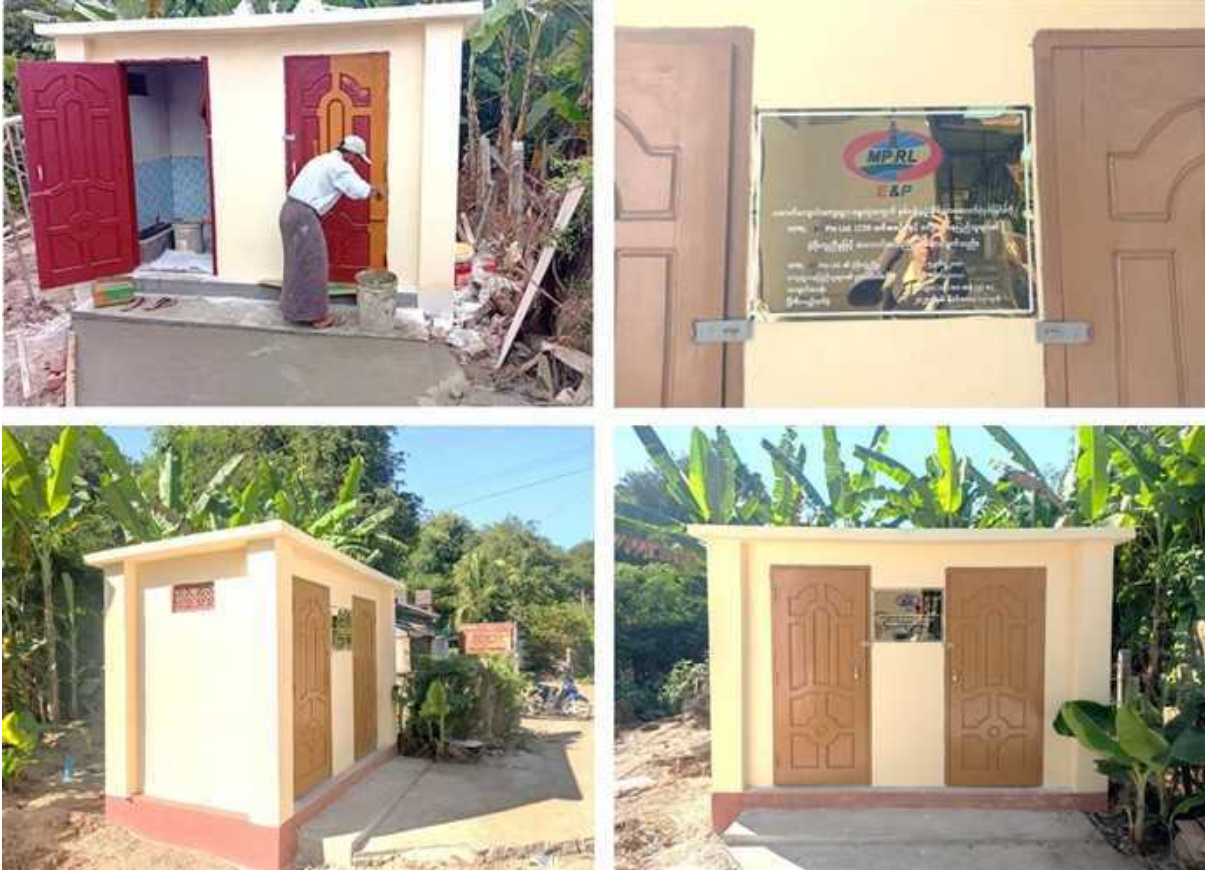
Figure 69: Completing Twin-pit Toilet Construction at Auk Kyaung Dhamayone

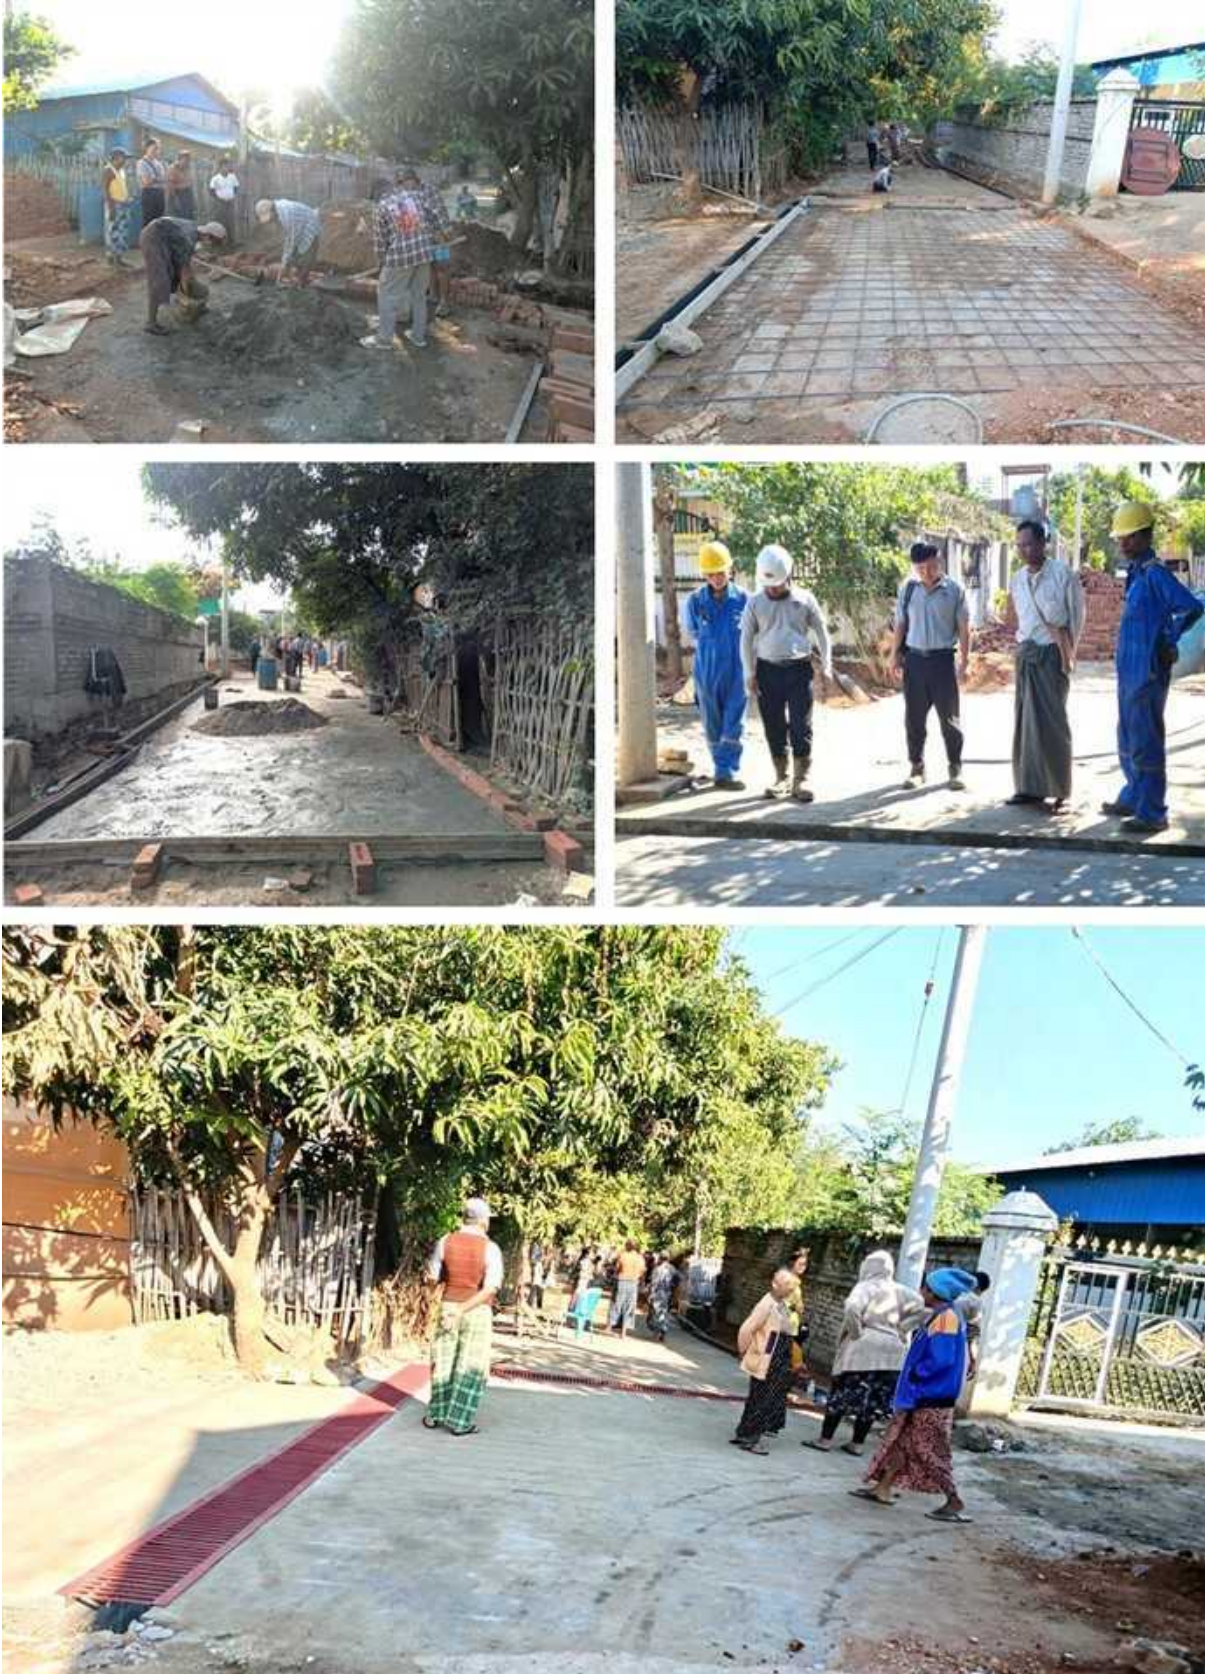
Figure 73: Completing Concrete Approach Road Construction and Drainage System in Aye Mya Village

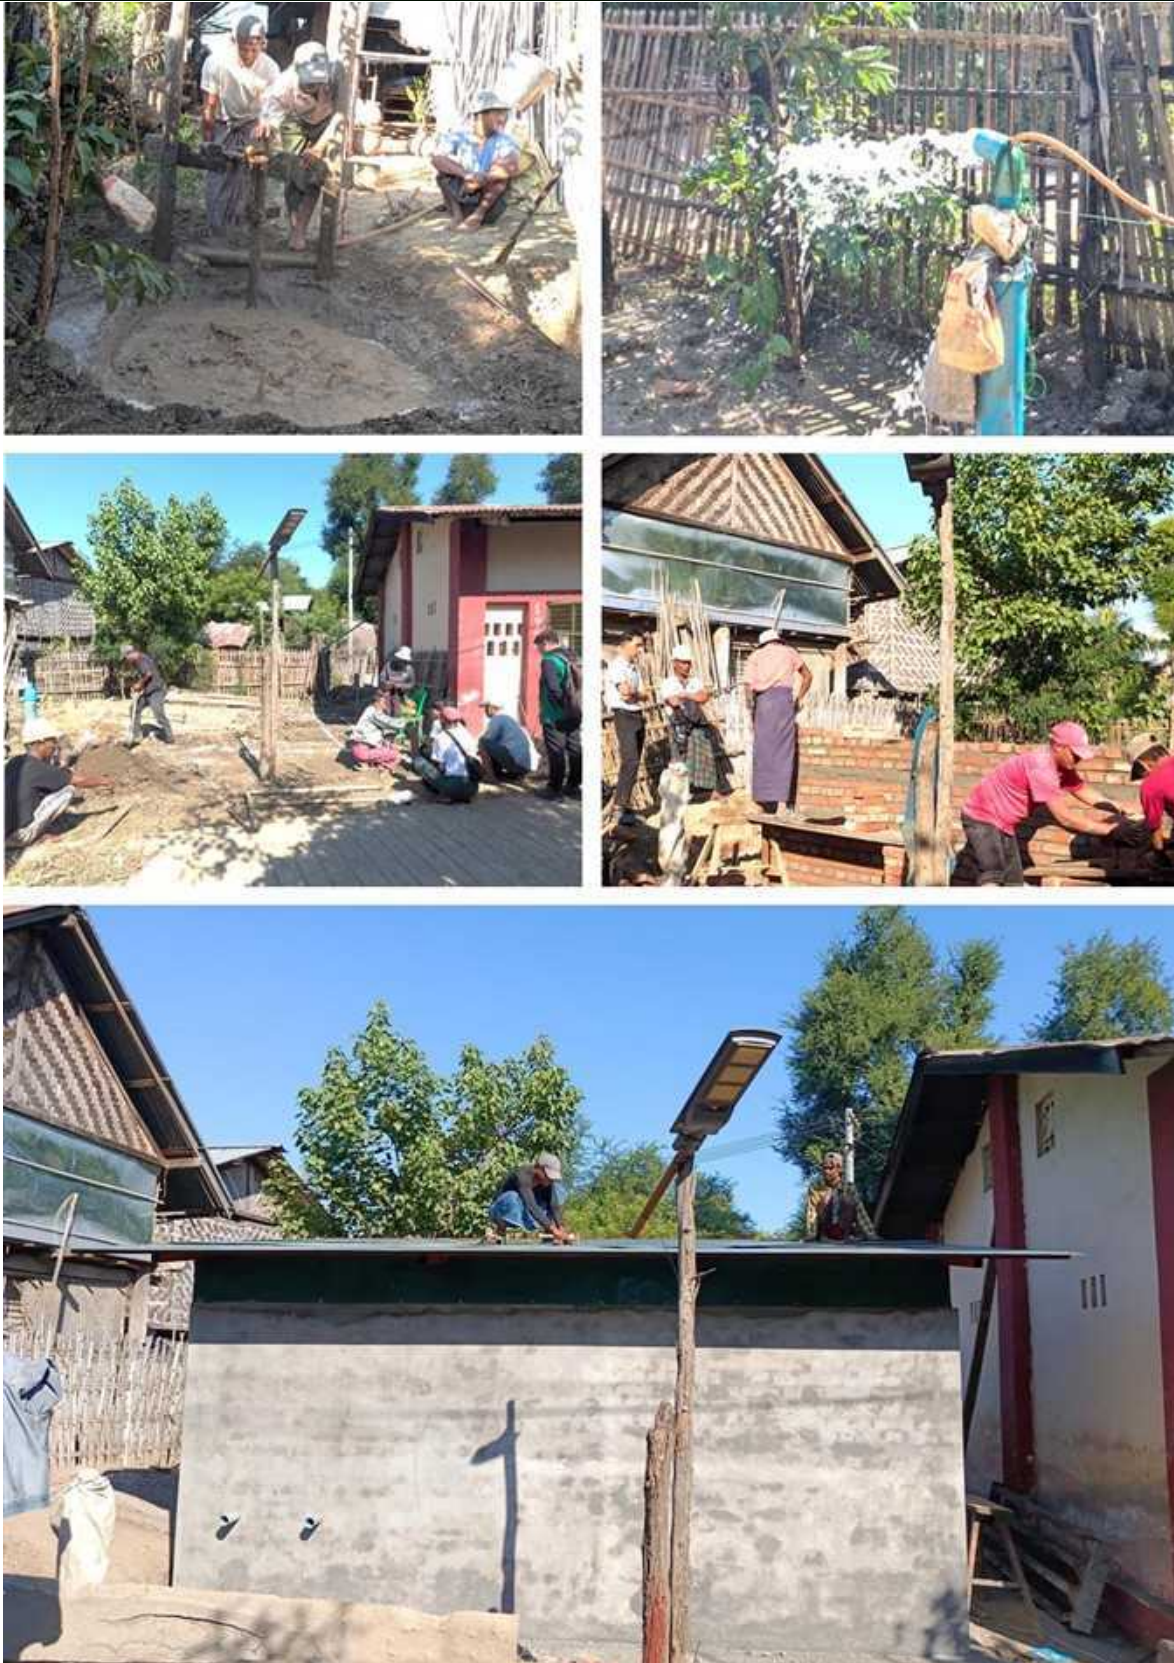
Figure 75: Monitoring Water Well Drilling, Concrete Water Tank Construction and Solar-Powered Water Pumping System in Chin Taung Village

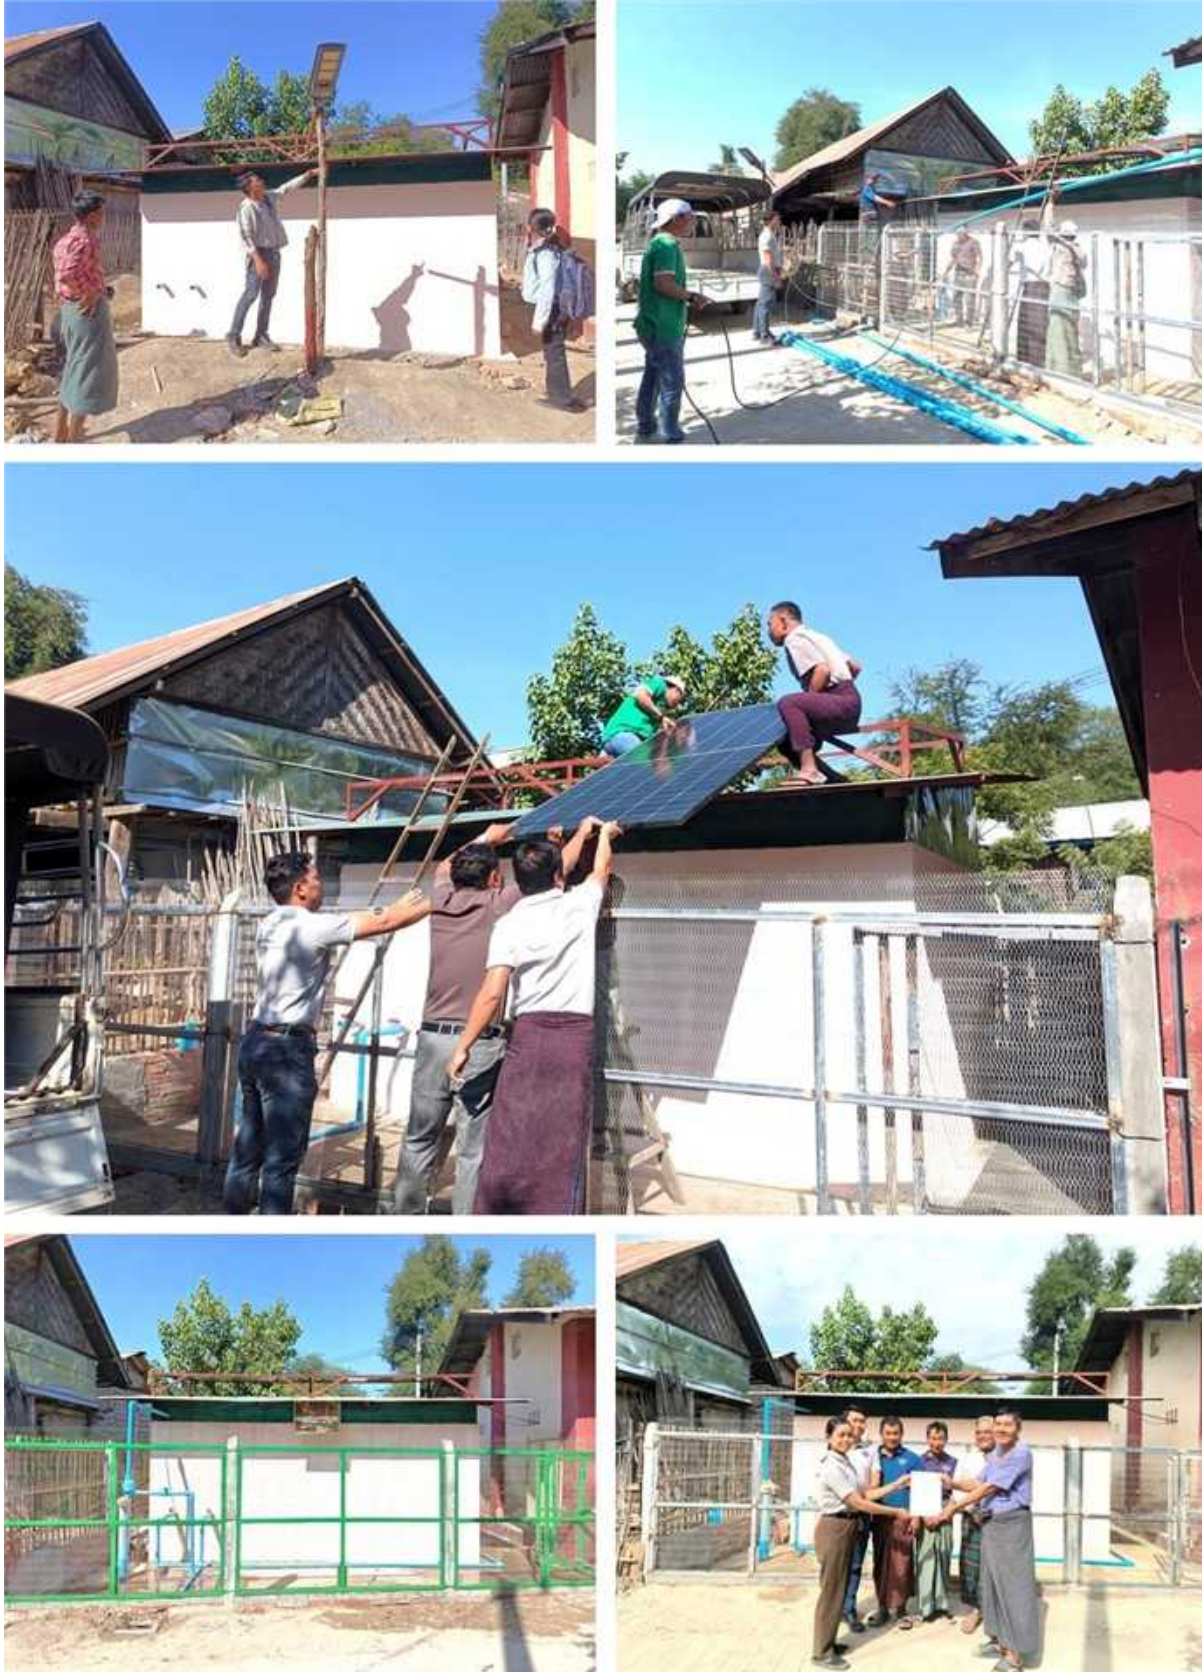
Figure 76: Completing Water Well Drilling, Concrete Water Tank Construction, and Solar-Powered Water Pumping System Installation at Chin Taung Village

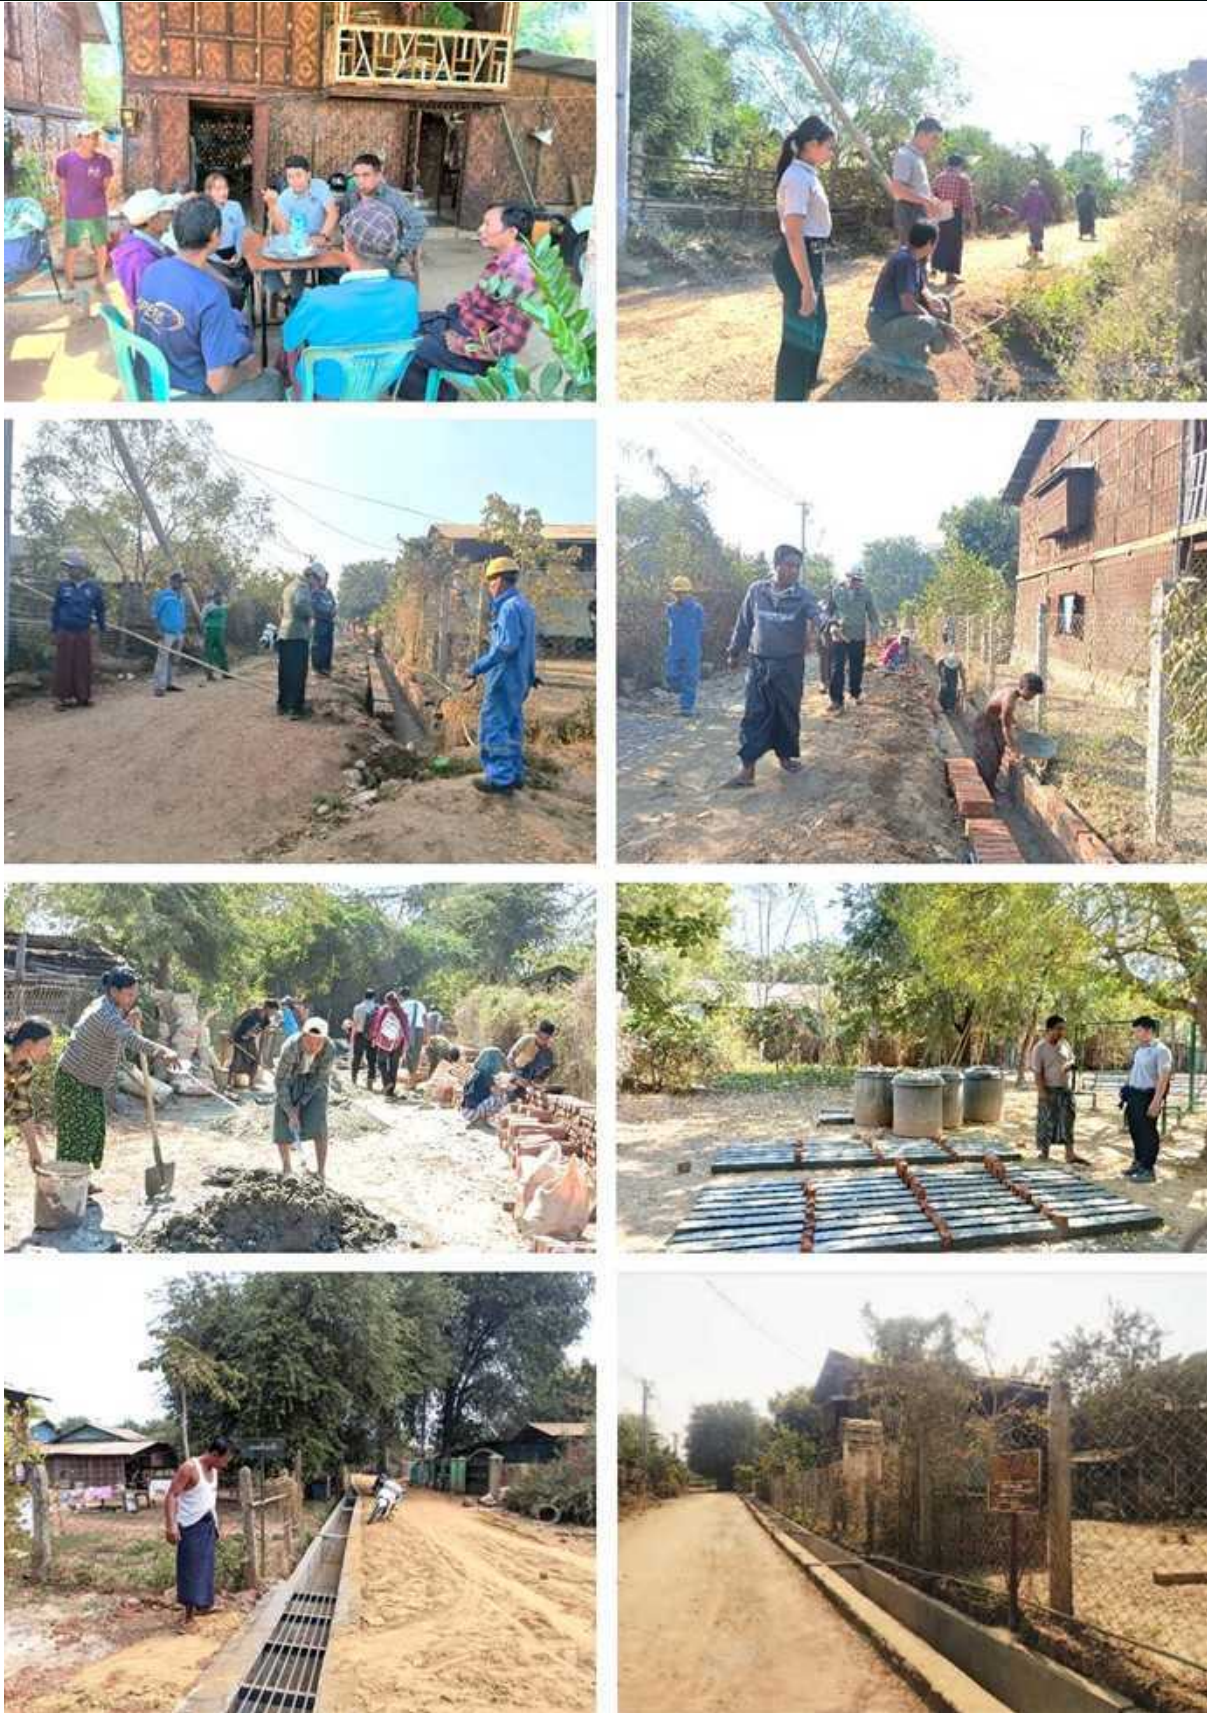
Figure 77: Completing Concrete Drainage System near Ma Kye Chaung School

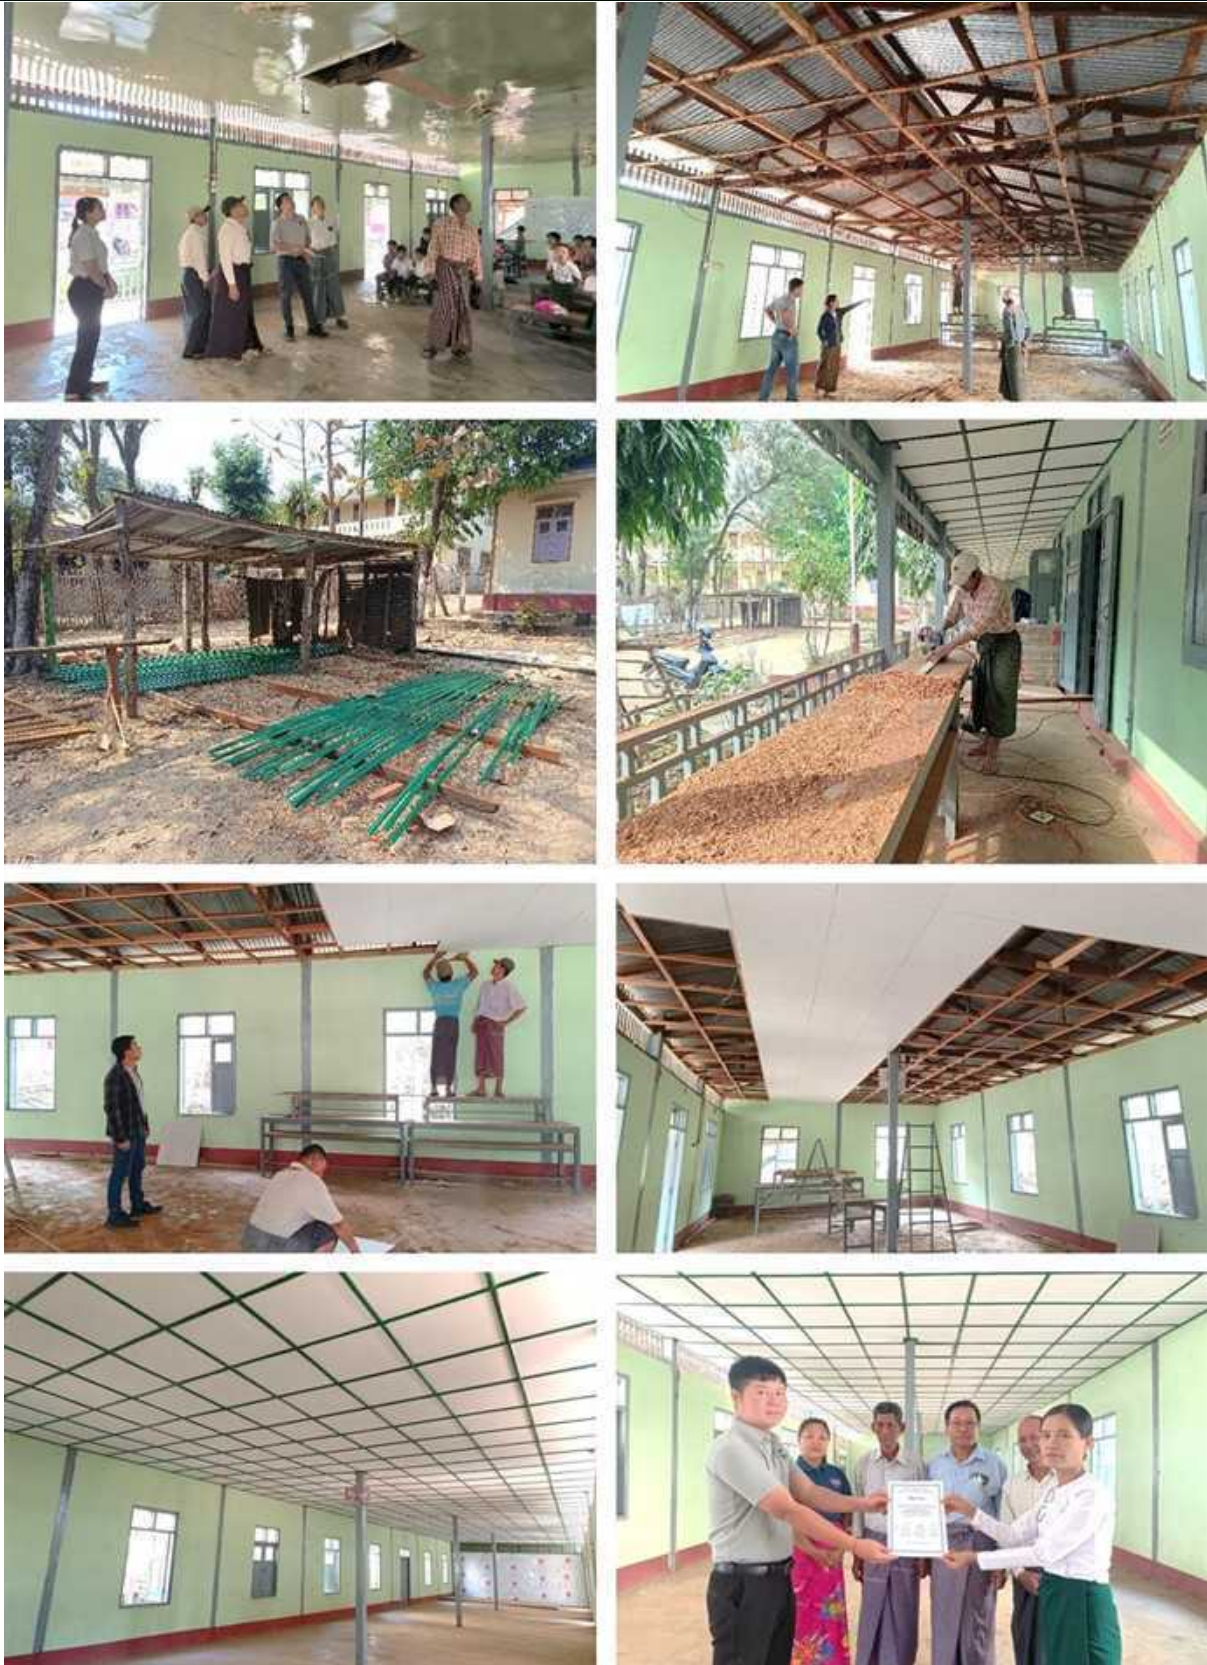
Figure 78: Completing Ceiling Installation at Lay Eain Tan Basic Education Middle School

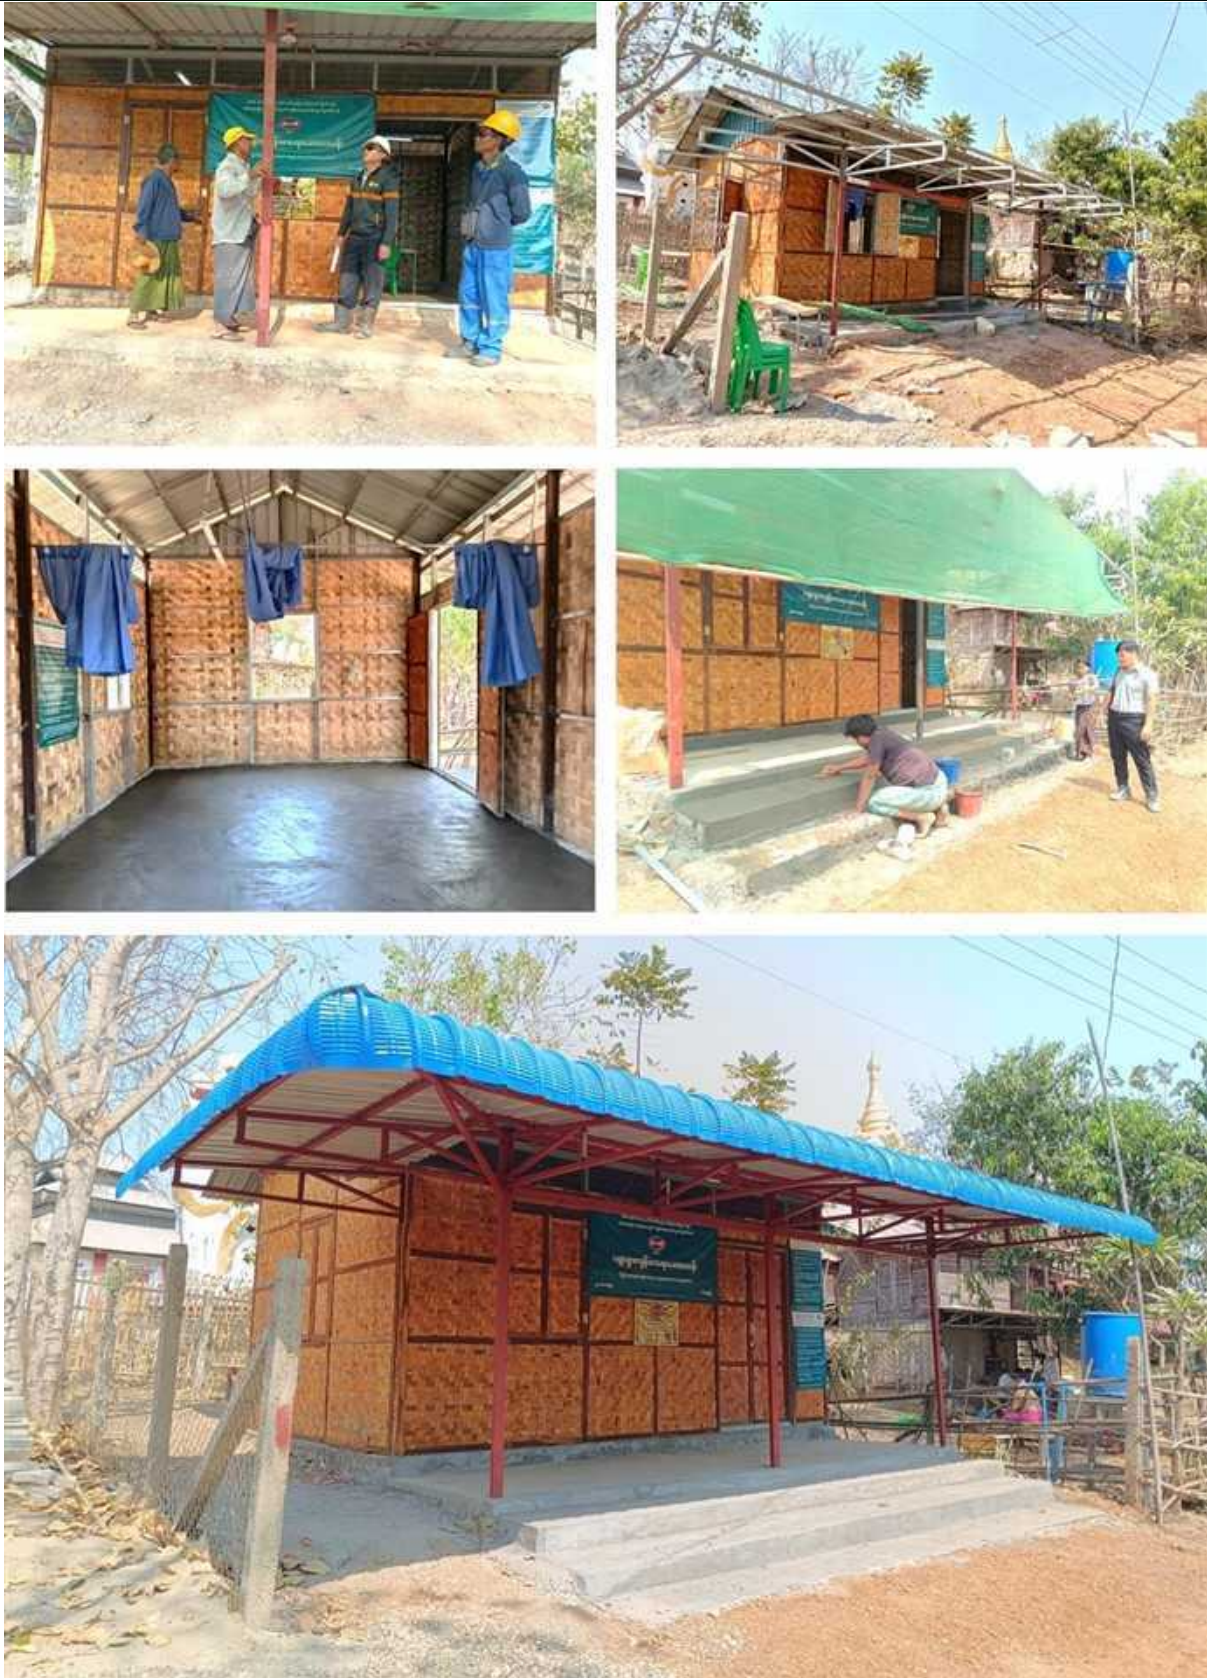
Figure 79: Completing Concrete Flooring and Sunshade Installation at the Former Library Site in Ywar Thar Village

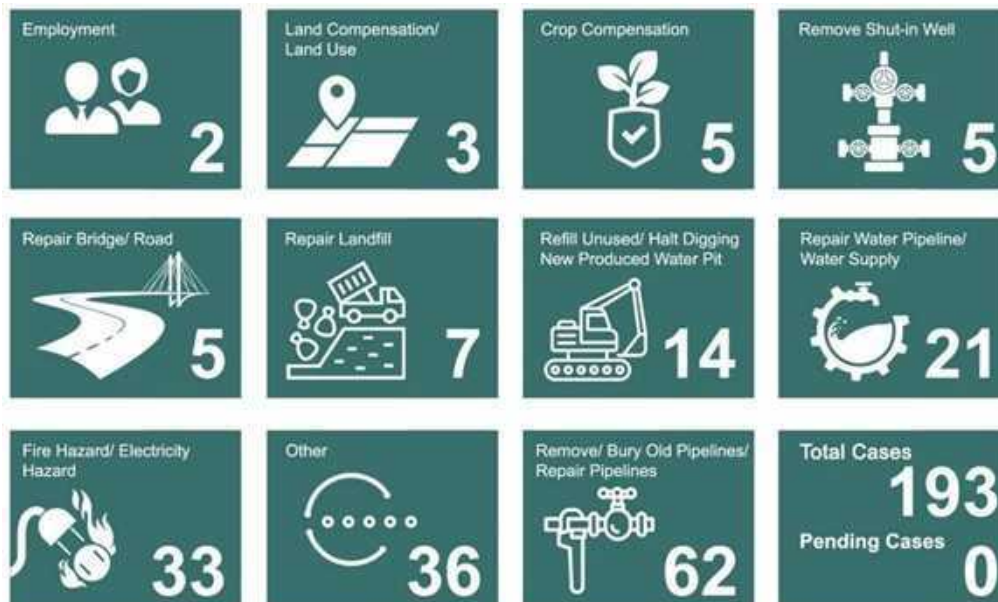
Figure 104: Key Performance Indicators of OGM in Mann Field

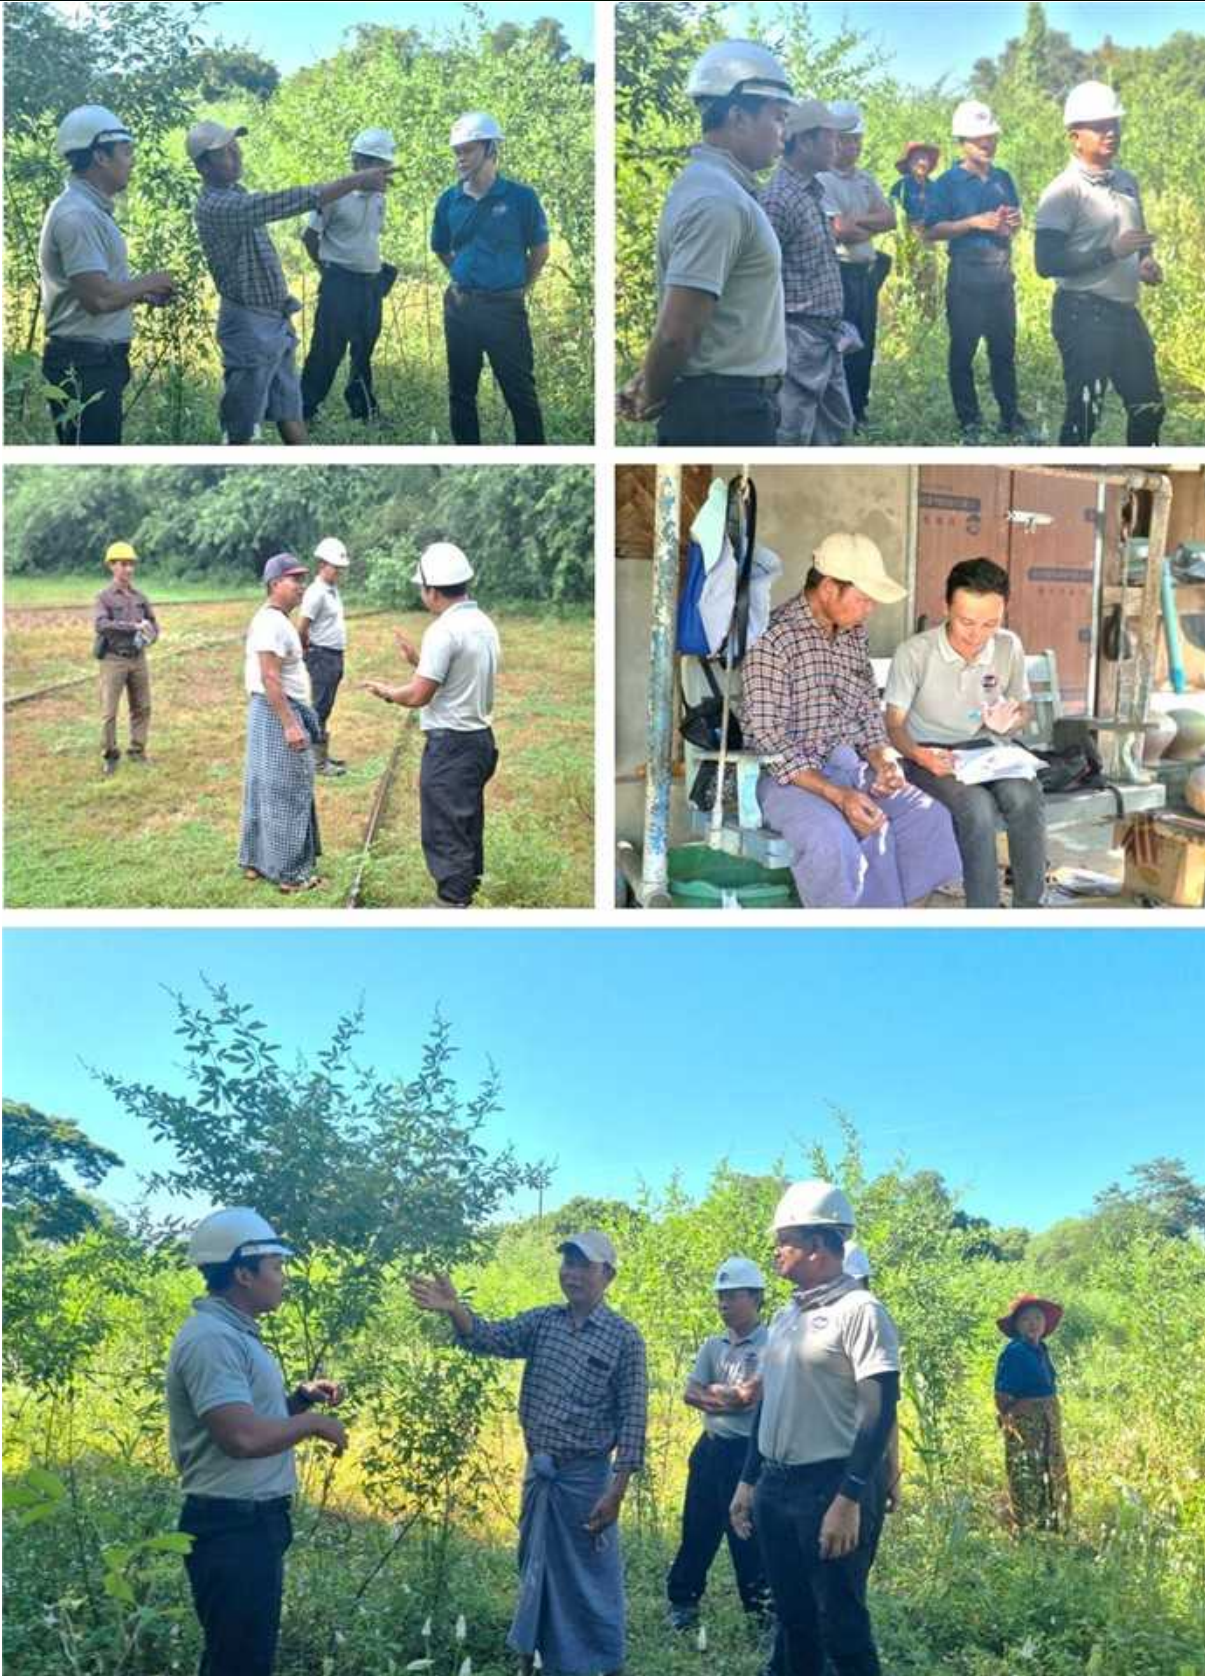
Figure 105: Received and Closed Cases, by Quarter, 2014-to-date

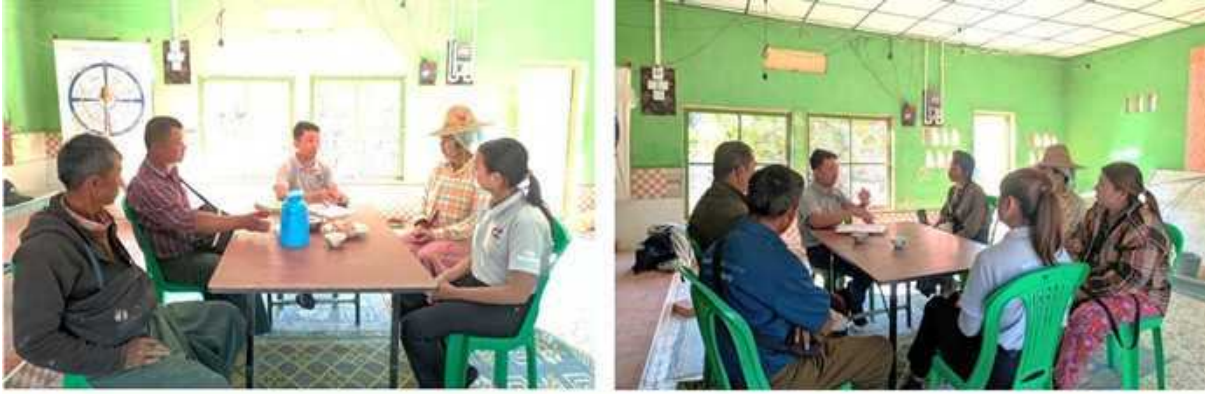
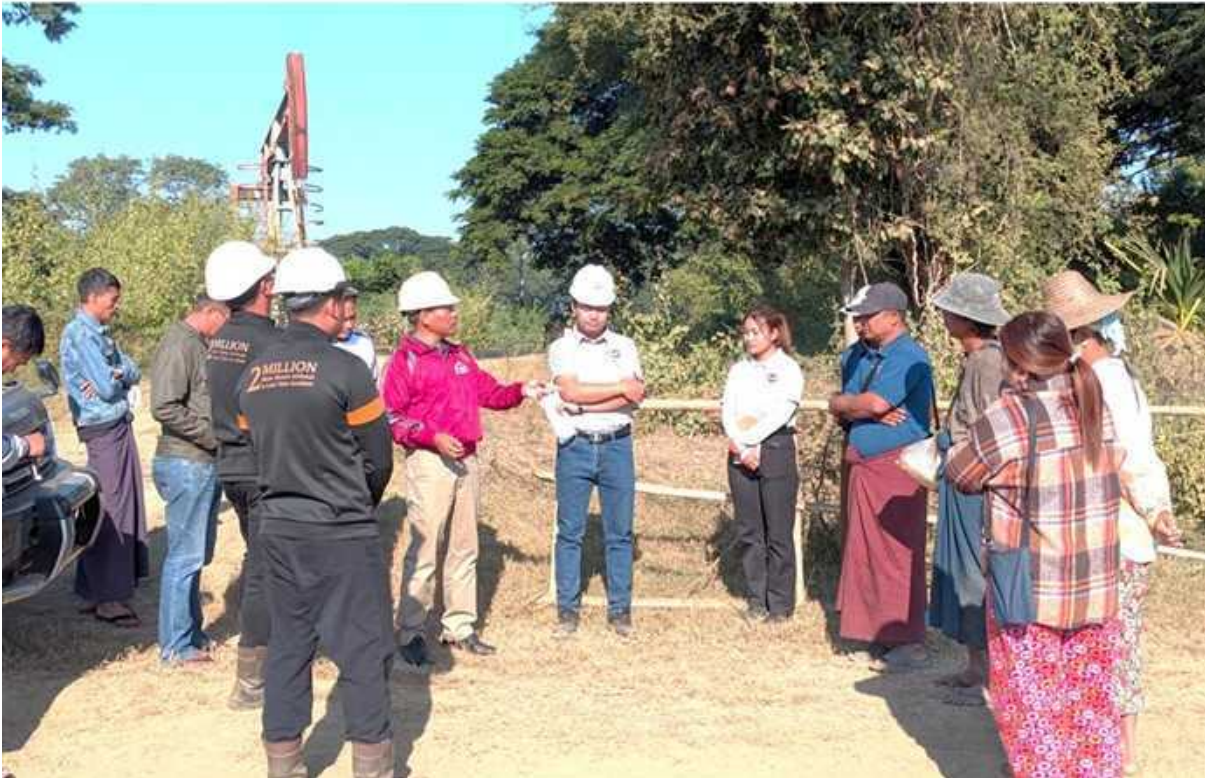
Figure 106: Addressing OGM Case in Lay Eain Tan Village

- On 14 November 2025, U Kyaw San from Lay Eain Tan Village reported that water from GOCS 2 was overflowing and entering his farmland, and requested inspection and repair. The Community Volunteer reported the case to CSRA-02, who subsequently informed the MPRL E&P Field Operations Team for inspection and follow-up. On 15 November 2025, the CSR Team and the Field Operations Team jointly conducted a site inspection. The inspection confirmed that there was no leakage from the GOCS 2 water source, and that the water observed in the complainant's farmland was residual rainwater. The findings were clearly explained to the complainant by both the Field Operations Team and the CSR Team. The complainant expressed satisfaction with the investigation process and the outcome.

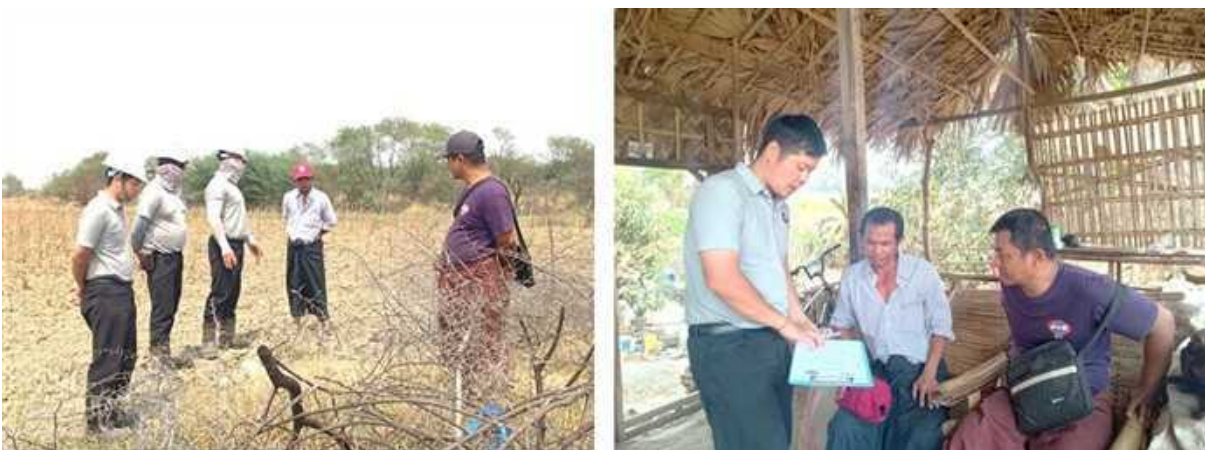
Figure 107: Addressing First OGM Case in Chin Taung Village

- On 24 December 2025, U Thein Than and Daw Thida Oo from Chin Taung Village reported that their farmland located near the newly constructed causeway was affected by dust generated during construction activities, resulting in crop damage. The case was reported by a Community Volunteer to CSRA-02, who subsequently escalated it to MPRL E&P's Field Operations Team and MOGE for inspection and follow-up actions. On 25 December 2025, the MOGE CSR Coordinator confirmed that discussions would be conducted and feedback would be provided to the affected farmers and the Village Administrator.
